## Geomorphic Effects of Logging Railbeds on an Ozarks Headwater Stream, Mark Twain National Forest, Missouri

A Masters Thesis

Master of Science, Geospatial Science in Geography and Geology

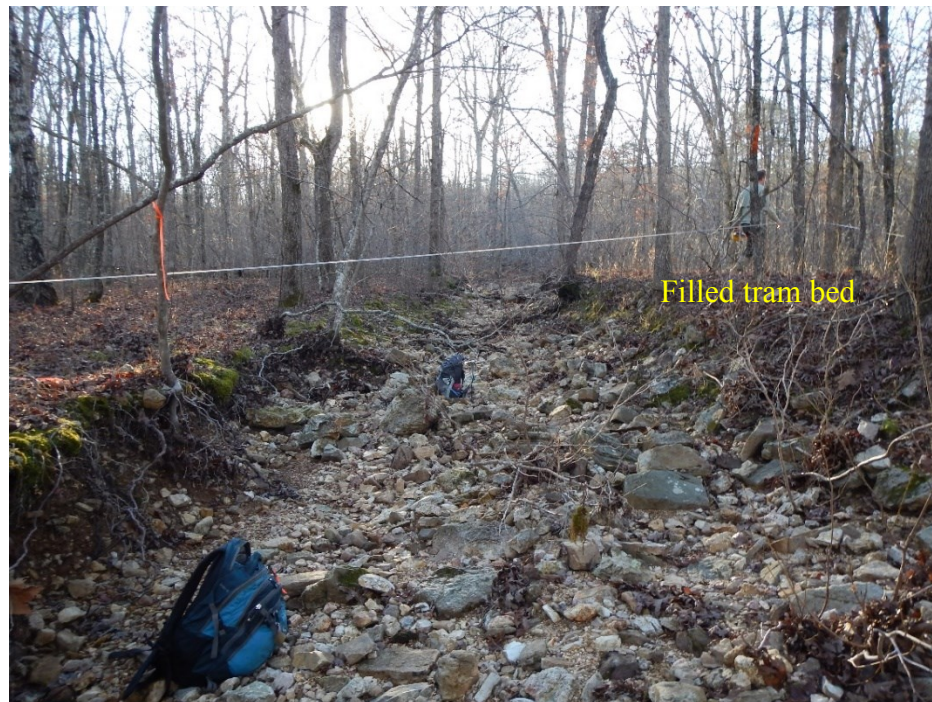
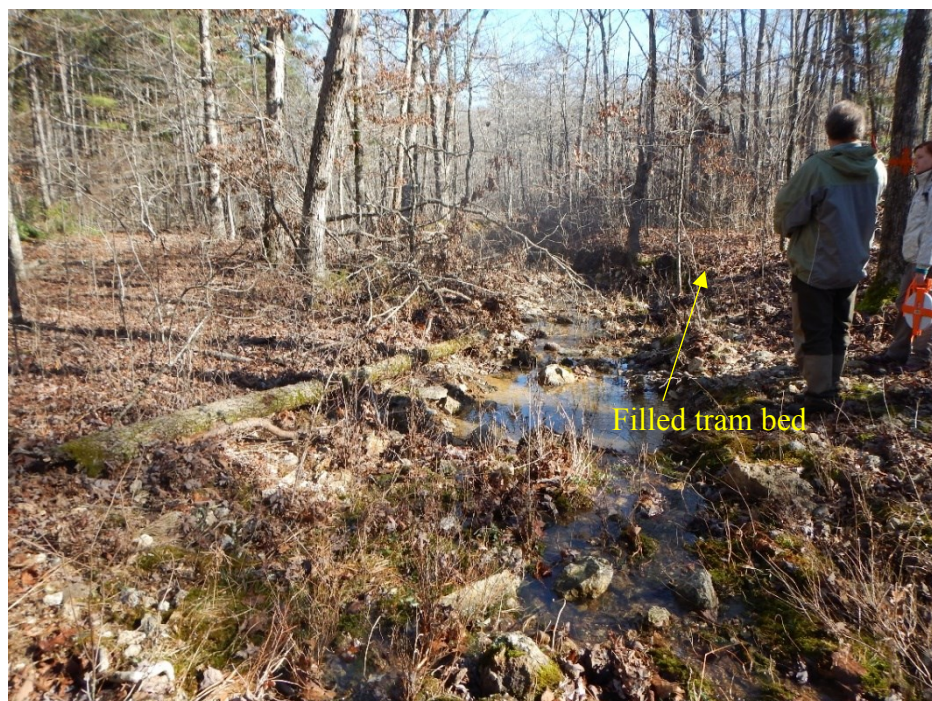
Figure 3. Filled Tram Bed Features in Tram Hollow: A.) Filled tram bed, R-km 1.17, B.) Filled tram bed, R-km 2.21. Pictures taken in December 2015 by Nick Bradley.

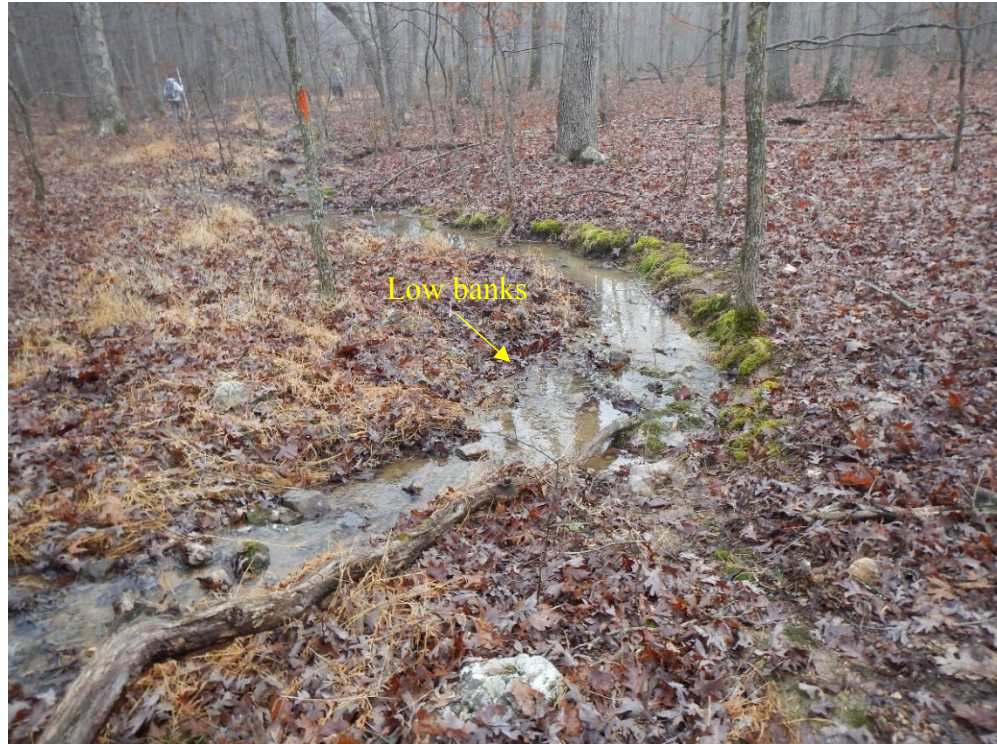
Figure 11. Natural Morphology Photos. A) Sinuous Pool Riffle, R-km 2.99, B) Colluvial channel with high w:d ratio, R-km 2.78. Photos taken in December 2015.

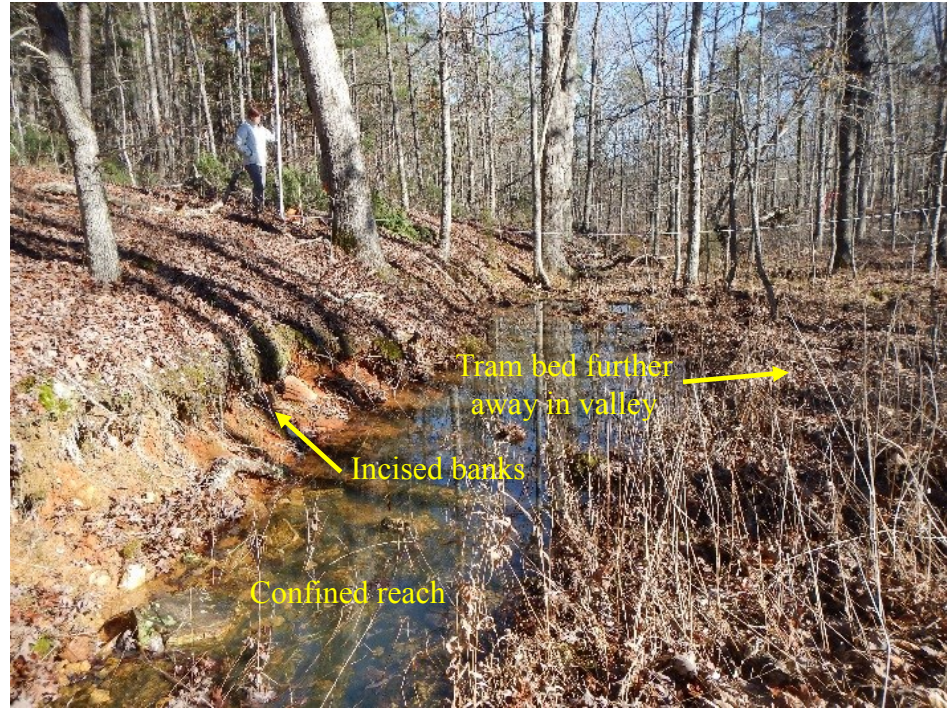
Figure 12. Confined Morphology Photos. A) Confined pool riffle channel along valley wall, R-km 2.36, B) Confined alluvial channel that had high w:d and low banks prior to tram construction, R-km 1.90. Photos taken in December 2015.

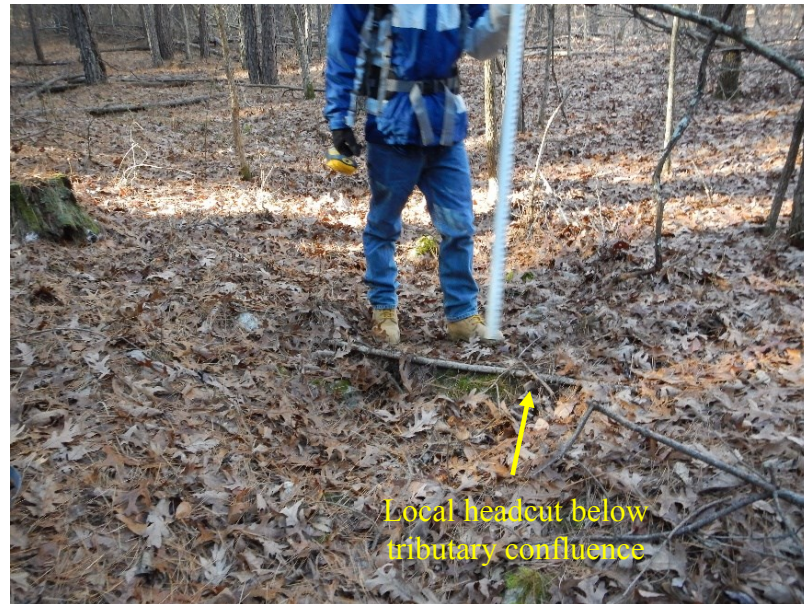
Figure 15. Local Headcut below Tributary Junction. R-km 2.70, December 2016.
