## Geomorphic Effects of Logging Railbeds on an Ozarks Headwater Stream, Mark Twain National Forest, Missouri

A Masters Thesis

Master of Science, Geospatial Science in Geography and Geology

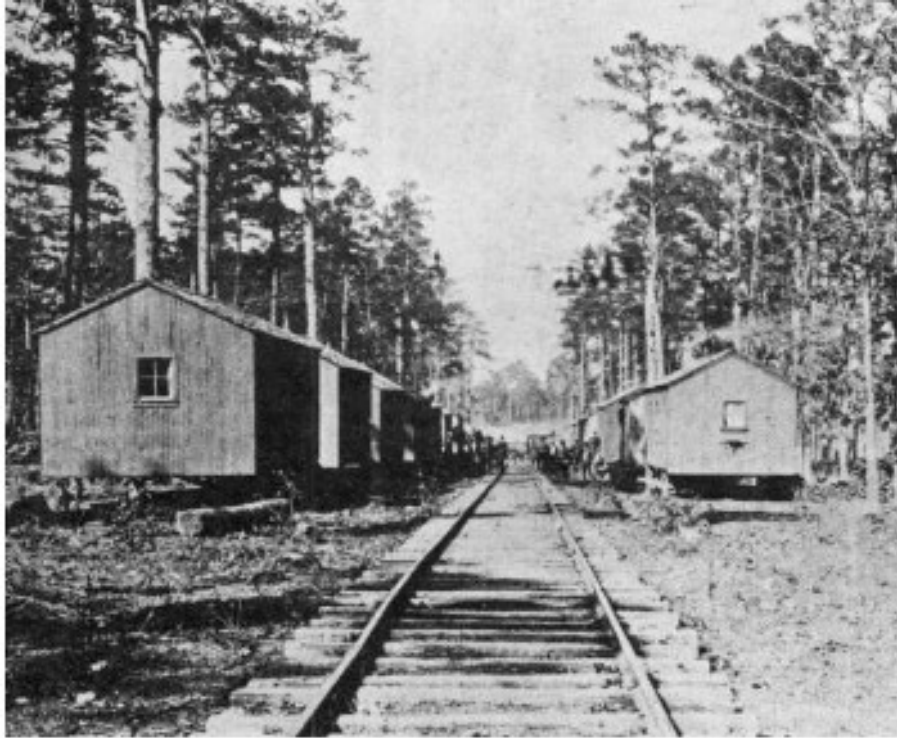
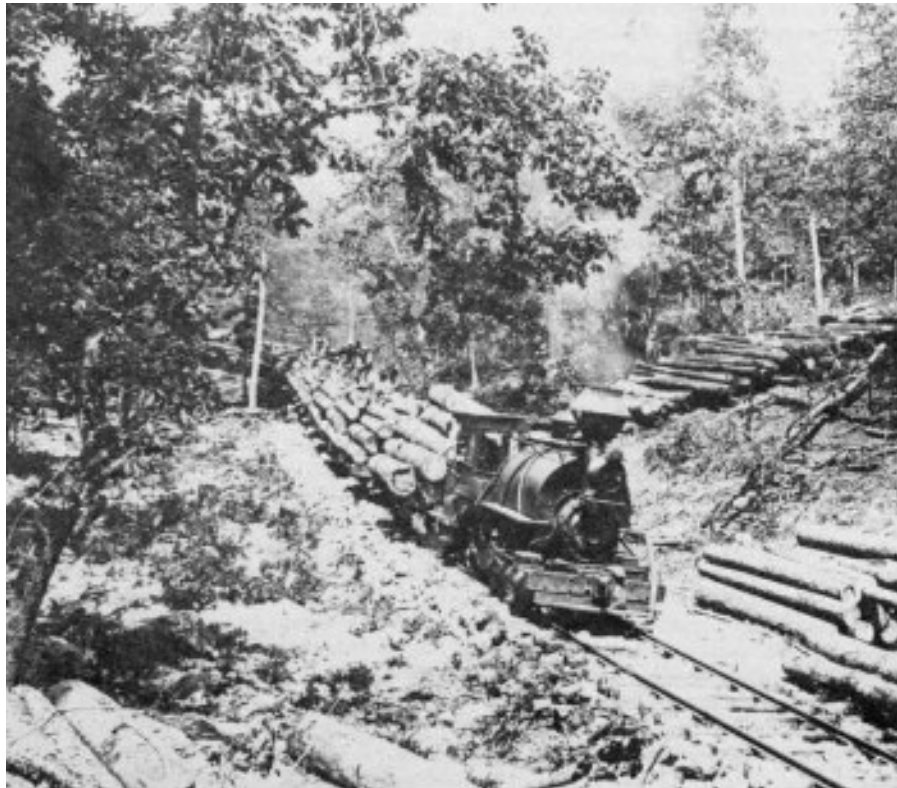
Figure 2. Logging Rail Systems in Missouri: A.) Mobile Logging Camp of the Cordz-Fisher Lumber Company, and B.) Log tram, Missouri Lumber and Mining Co., 1907. Reference: Ozarks Watch, Vol. VI., No. 1, 1992.

the mid-1940s to support logging activities (Guyette and Larsen, 2000) (Figure 2). Logging rail roads were constructed parallel to river channels, often in the floodplains, because more gradual slopes permitted easier access and transportation for the logging industry. The rail beds from this old network of logging trams still remain in several Ozark watersheds (Jacobson and Primm, 1997; Strausberg and Hough, 1997; Guyette and Larsen, 2000; Benac and Flader, 2004). Evidence includes cut tram beds, filled tram beds, boulder lines bordering filled tram beds along streams, and old bridge materials (Guyette and Larsen, 2000) (Figure 3 and Figure 4). No studies have previously evaluated the effects of these abandoned rail systems on channel disturbances such as channel straightening, flow obstruction, and valley confinement in the Ozarks. The

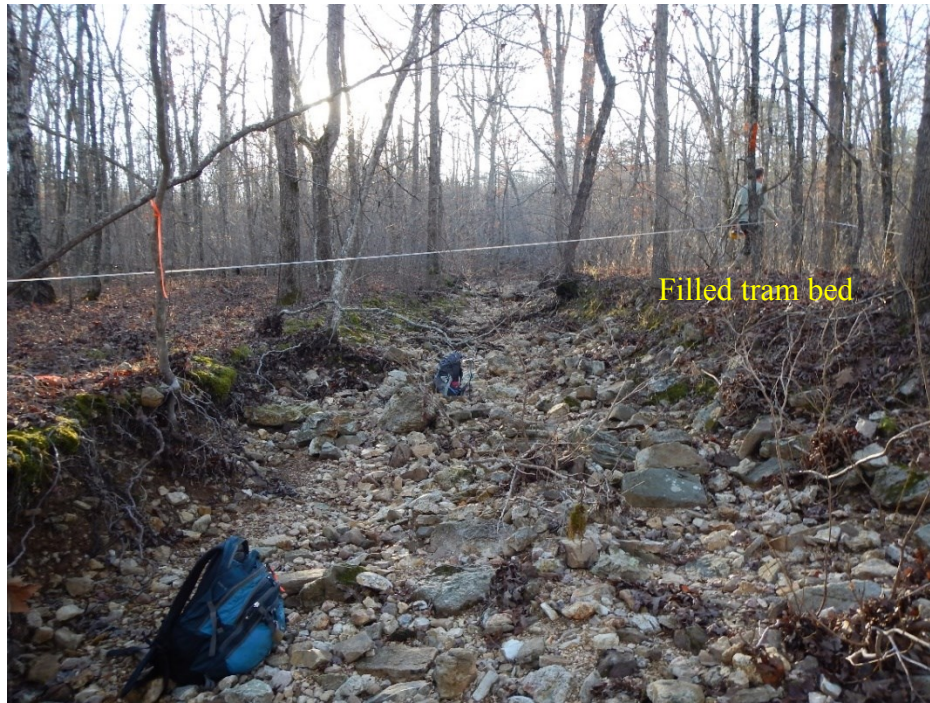
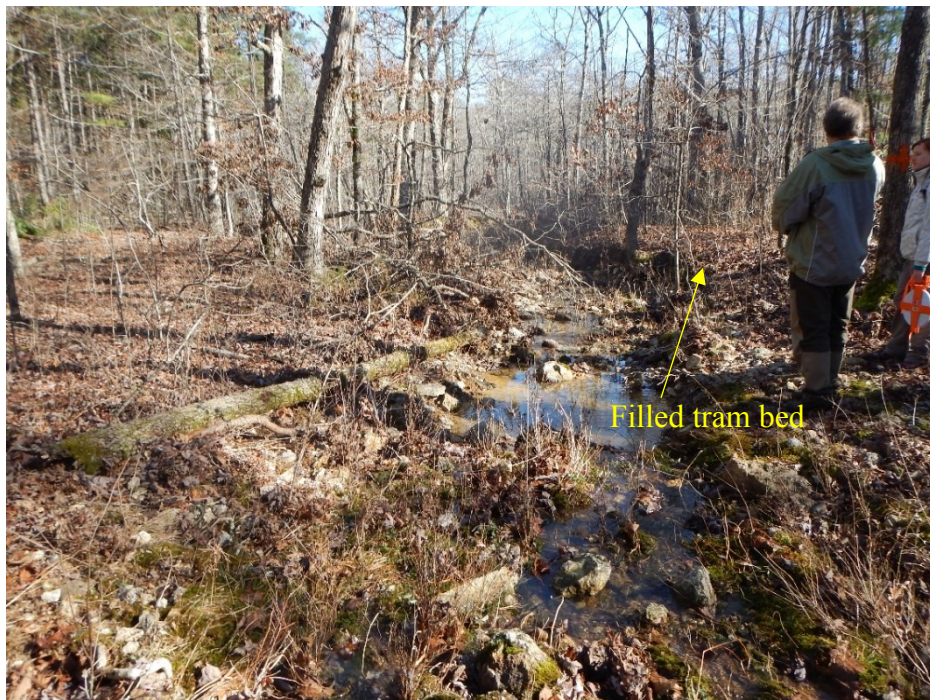
Figure 3. Filled Tram Bed Features in Tram Hollow: A.) Filled tram bed, R-km 1.17, B.) Filled tram bed, R-km 2.21. Pictures taken in December 2015 by Nick Bradley.

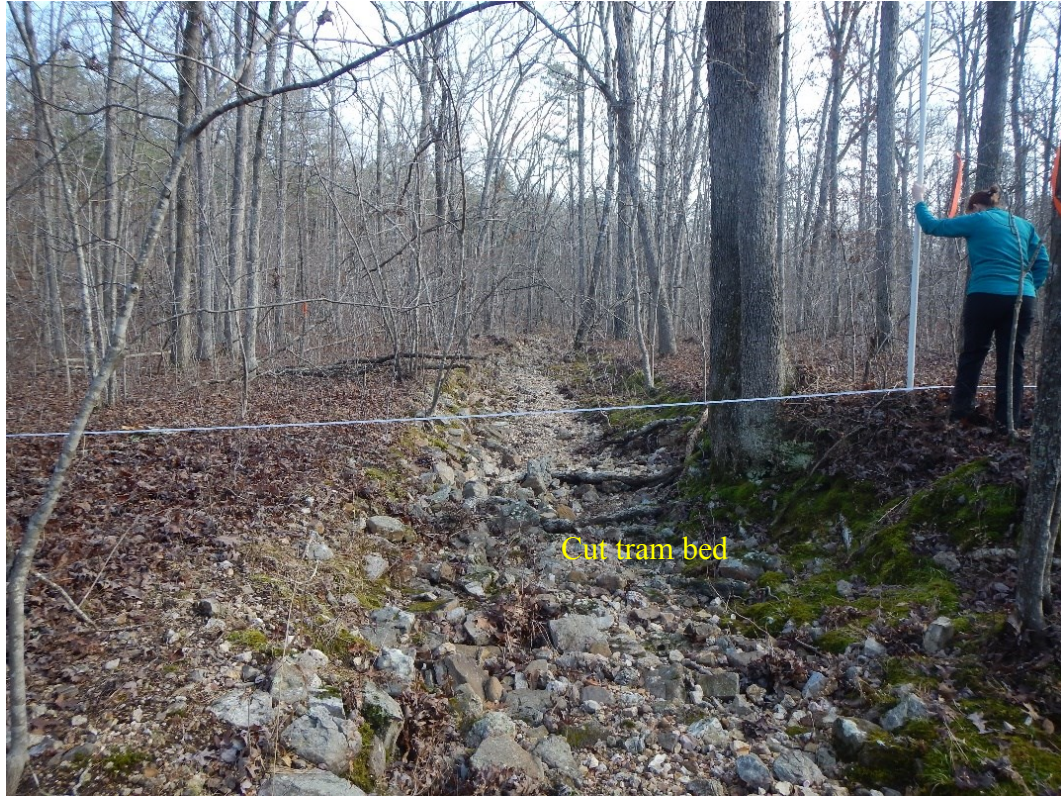
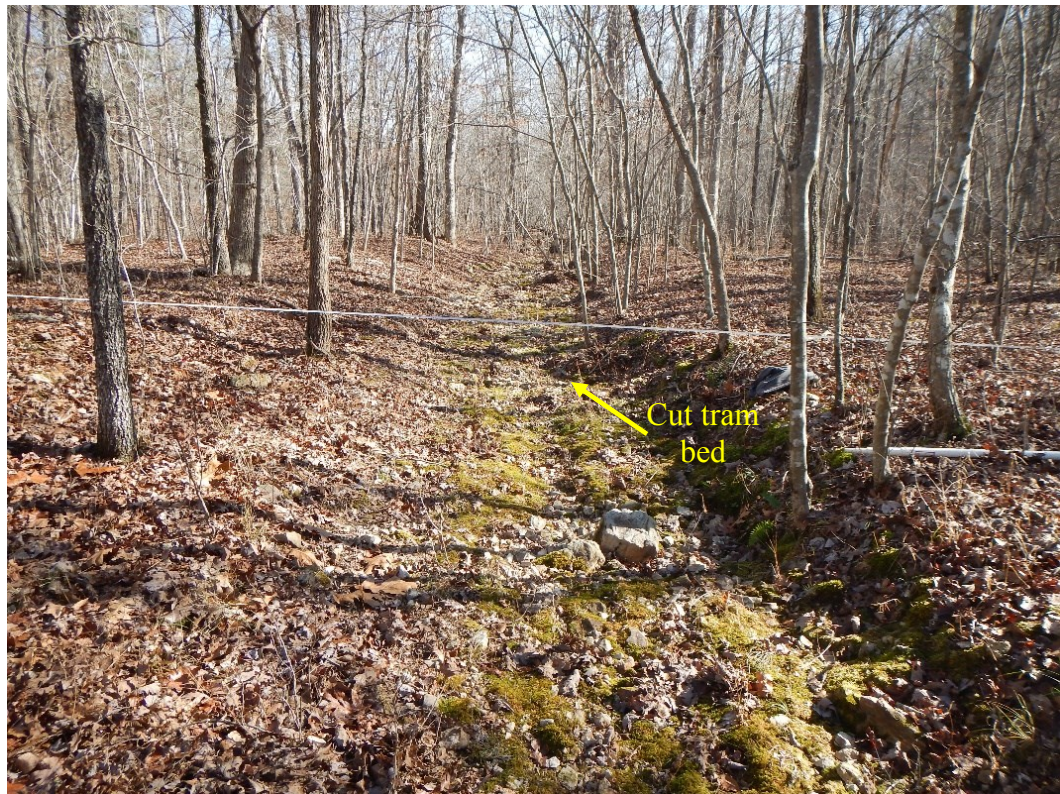
Figure 4. Cut Tram Bed Features in Tram Hollow A.) Cut tram bed, R-km 0.93, B.) Cut tram bed, R-km 0.60. Pictures taken in December 2015.

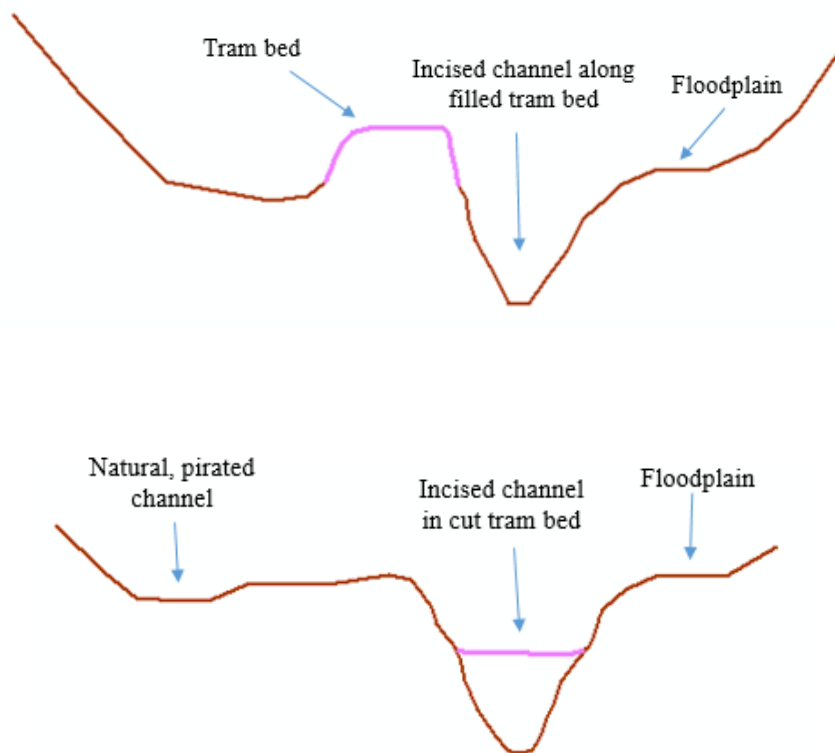
Figure 10. Tram Bed Forced Morphology. The tram bed directly forces a disturbed morphology on the channel system. The diagram further above depicts incision along a filled tram bed, and the diagram directly above depicts incision in a cut tram bed.

Tram bed-forced morphology occurs where the tram bed has direct effects on channel morphology, including channel incision, piracy of flow from the natural channel, and causing channels to be located in new locations within the valley (Florsheim et al., 2000; Gilvear and Winterbottom, 1992; Winterbottom, 2000). The tram bed forms a boundary or obstacle within the channel. There are two tram bed-forced sub-classes: (1) natural and tram drain channels coalesce into a single planform along filled tram beds, and (2) incised cut tram beds that pirate flow from the natural channel with increases in stream power (Table 4; Figure 10; Figure 13).

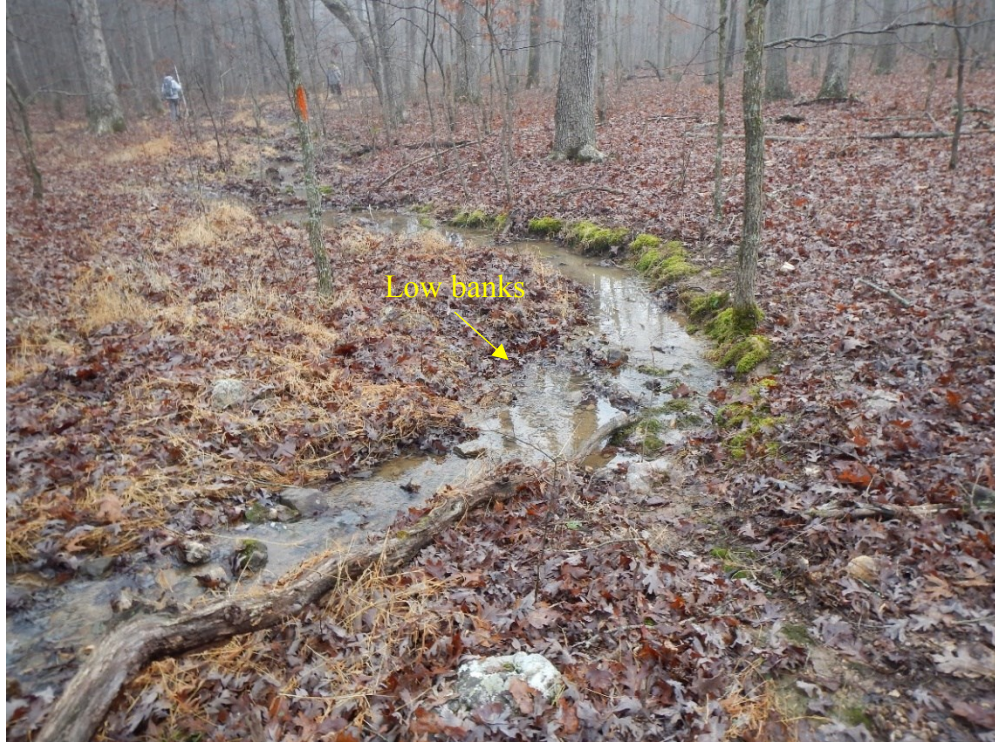
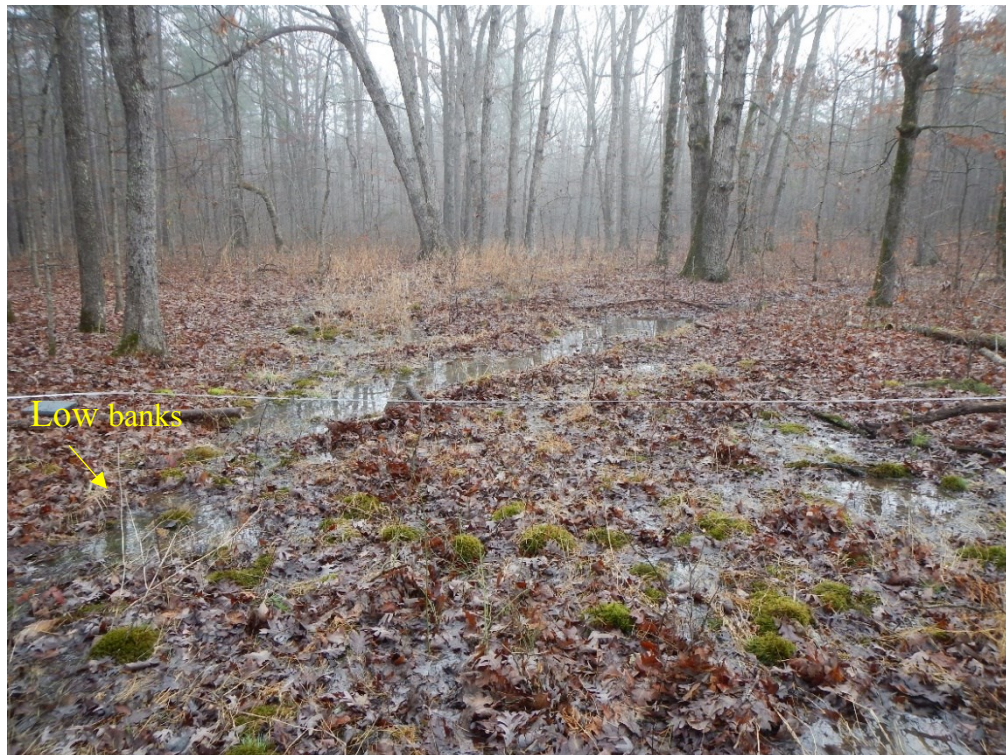
Figure 11. Natural Morphology Photos. A) Sinuous Pool Riffle, R-km 2.99, B) Colluvial channel with high w:d ratio, R-km 2.78. Photos taken in December 2015.

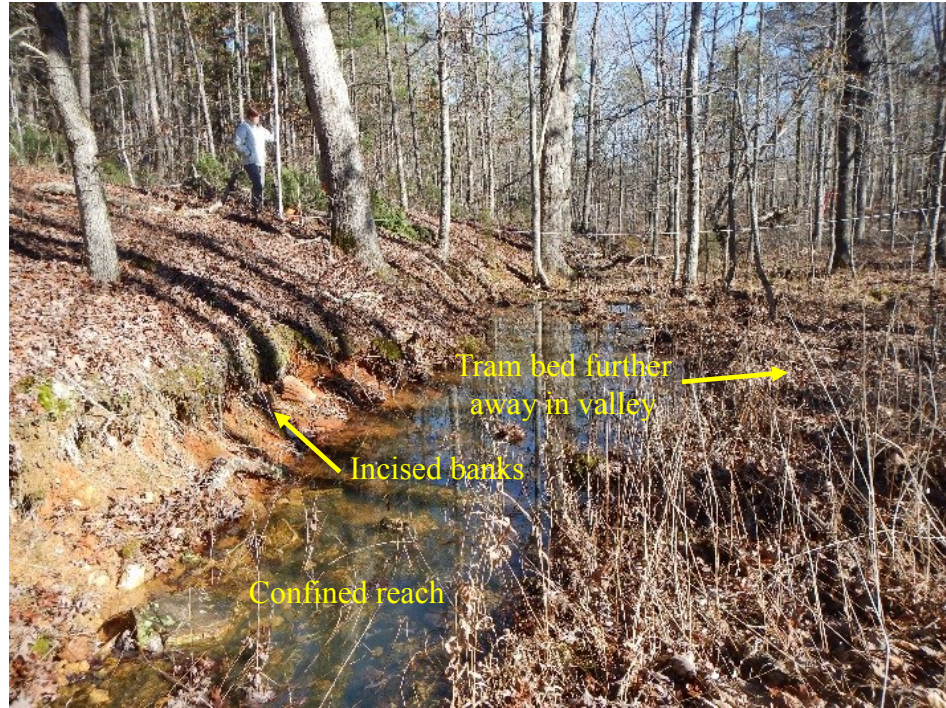
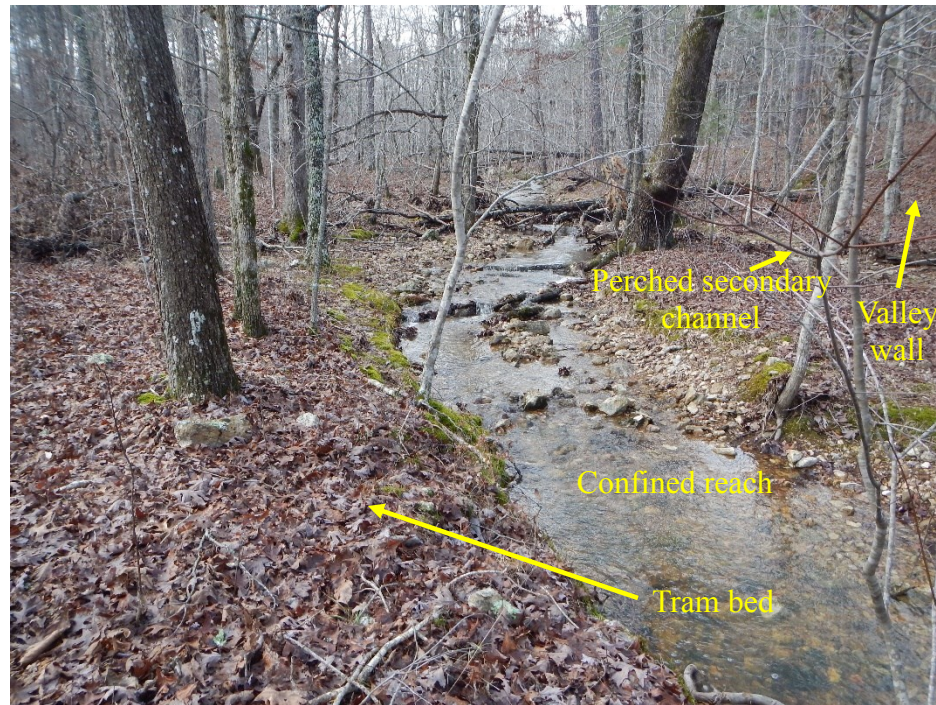
Figure 12. Confined Morphology Photos. A) Confined pool riffle channel along valley wall, R-km 2.36, B) Confined alluvial channel that had high w:d and low banks prior to tram construction, R-km 1.90. Photos taken in December 2015.

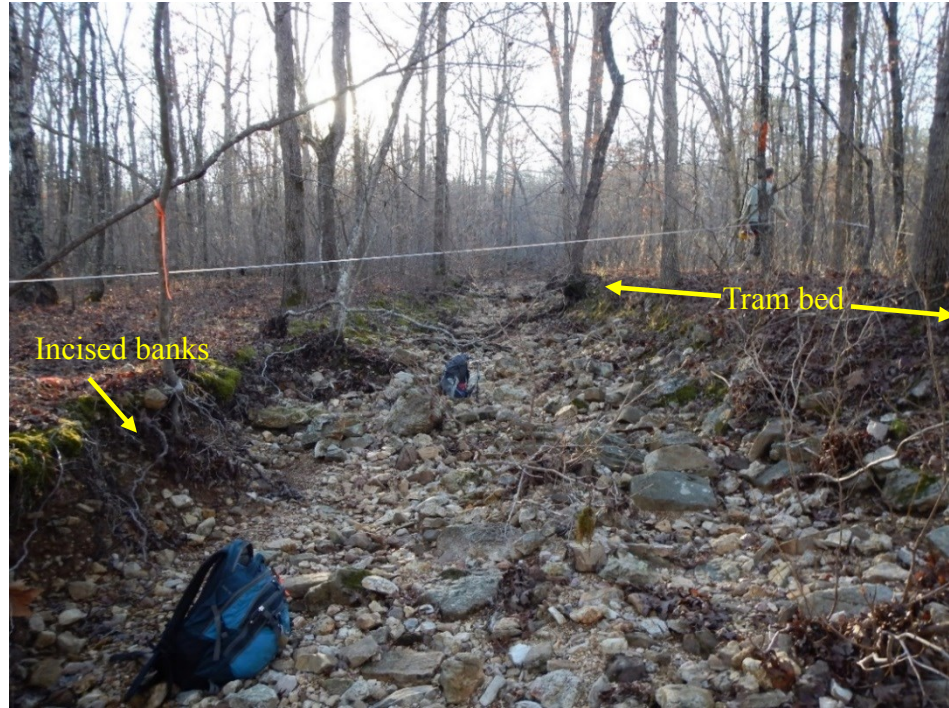
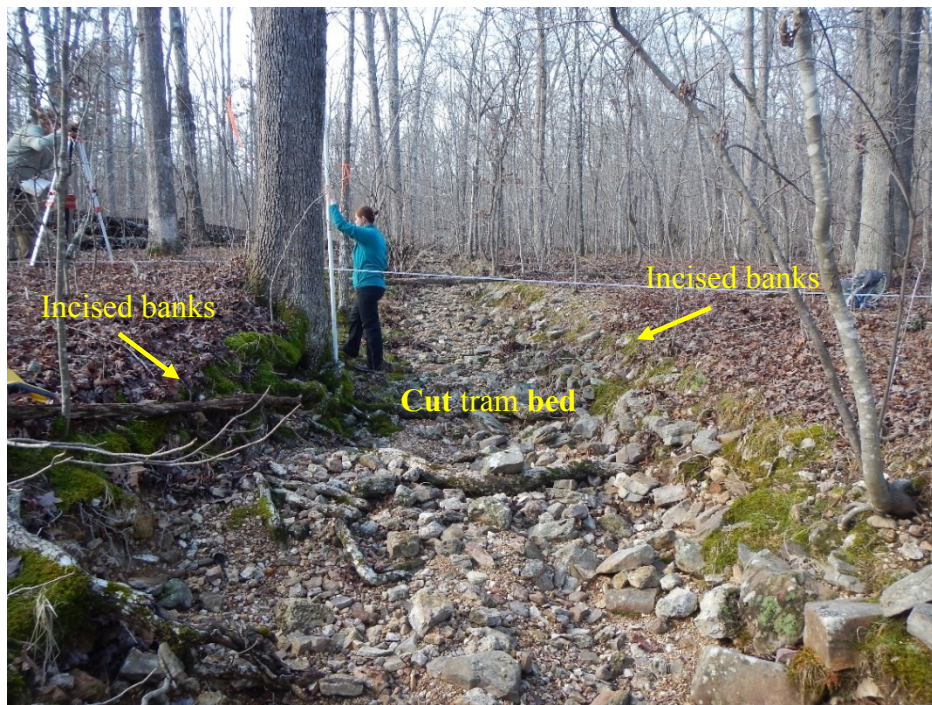
Figure 13. Tram Bed Forced Morphology Photos. A) Incised channel along filled tram bed, R-km 1.17, B) Incised channel in cut tram bed, R-km 0.93. Photos taken Dec. 2015.

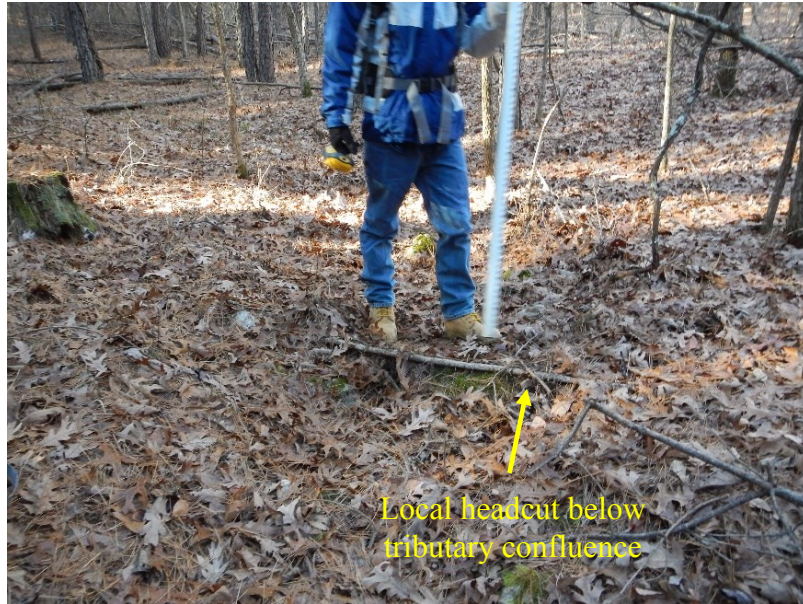
Figure 15. Local Headcut below Tributary Junction. R-km 2.70, December 2016.

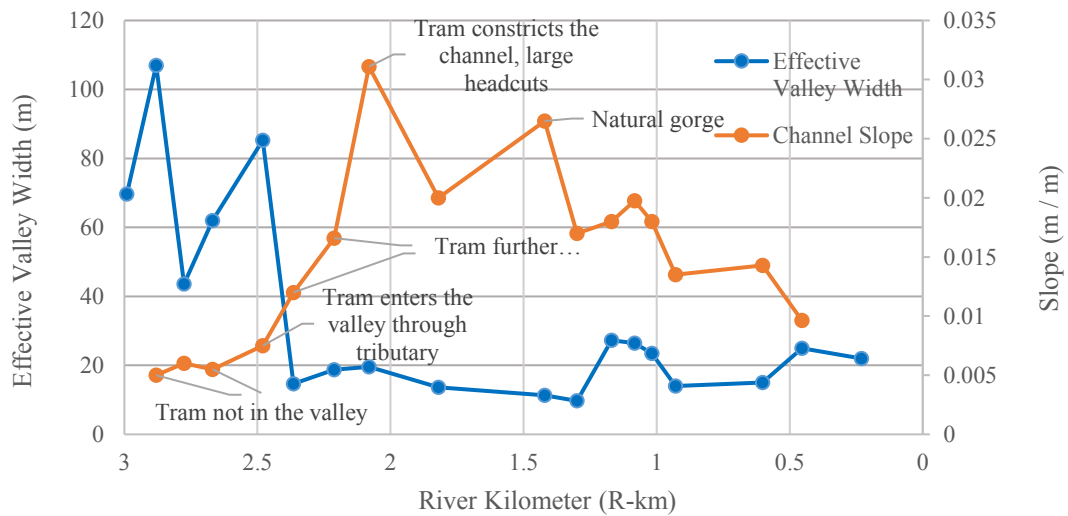
Figure 19. Longitudinal Trends of Effective Valley Width and Channel Slope. The tram bed confines the effective valley width.

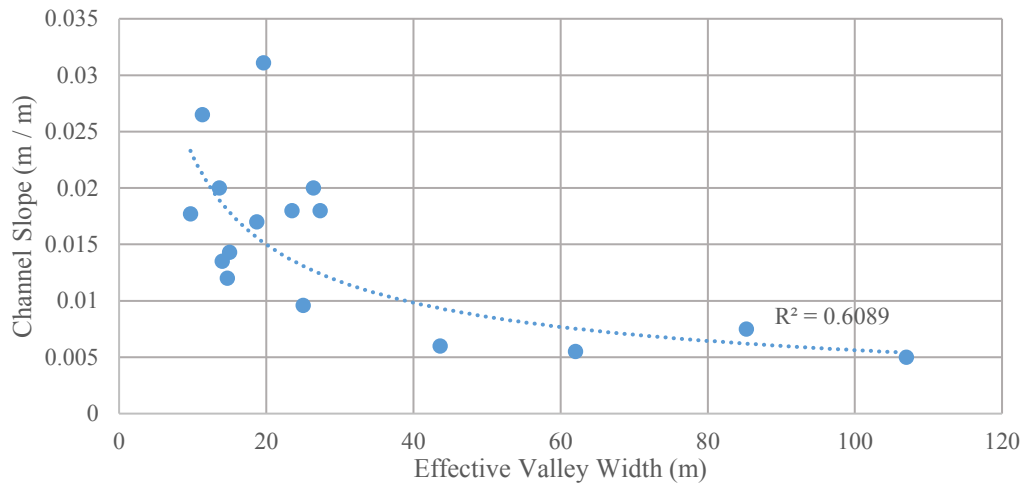
Figure 20. Effective Valley Width versus Channel Slope.

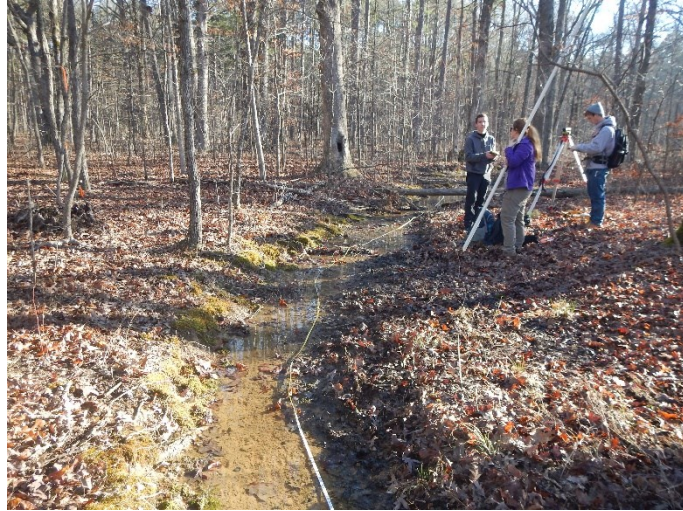
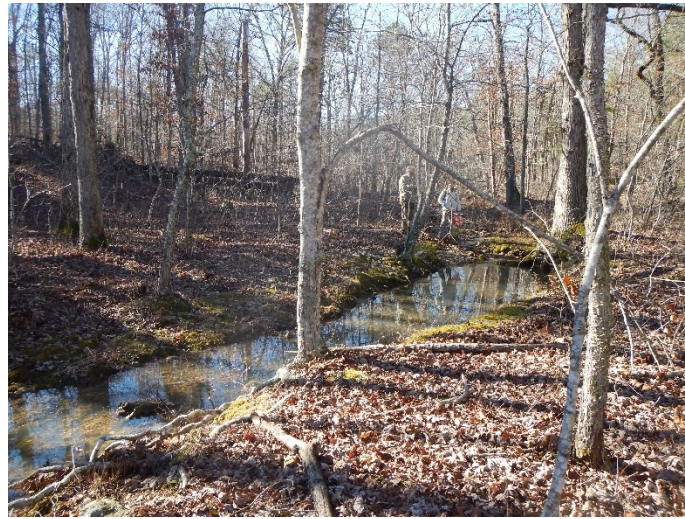
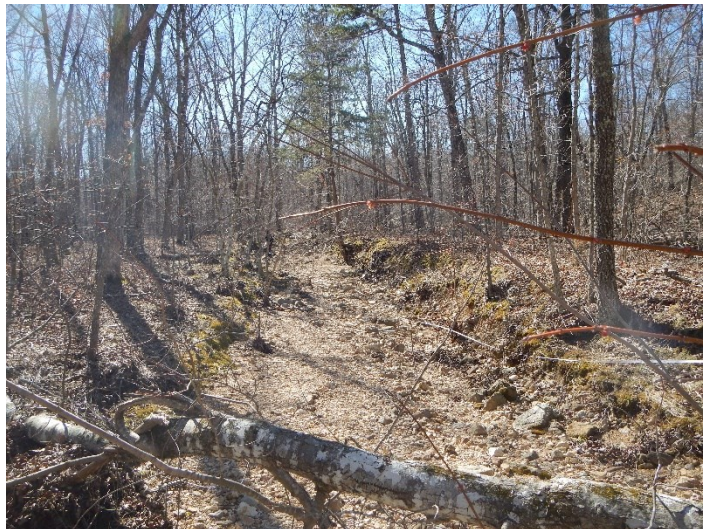
Figure 23. Longitudinal Profile Sites. A) R-km 2.78, B) R-km 2.08, and C) R-km 1.17. Photos taken in March 2016.

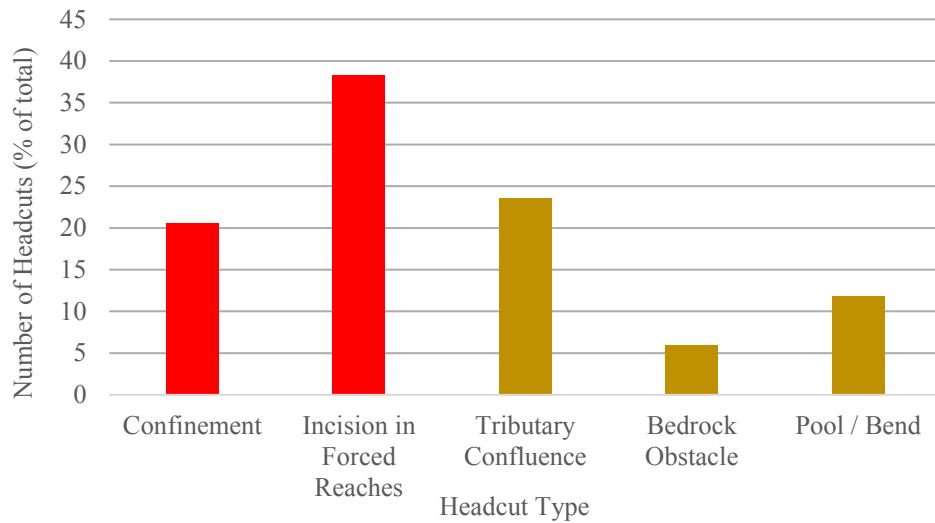
Figure 24. Headcut Count. Red indicates tram headcuts, and brown indicates localized headcuts.

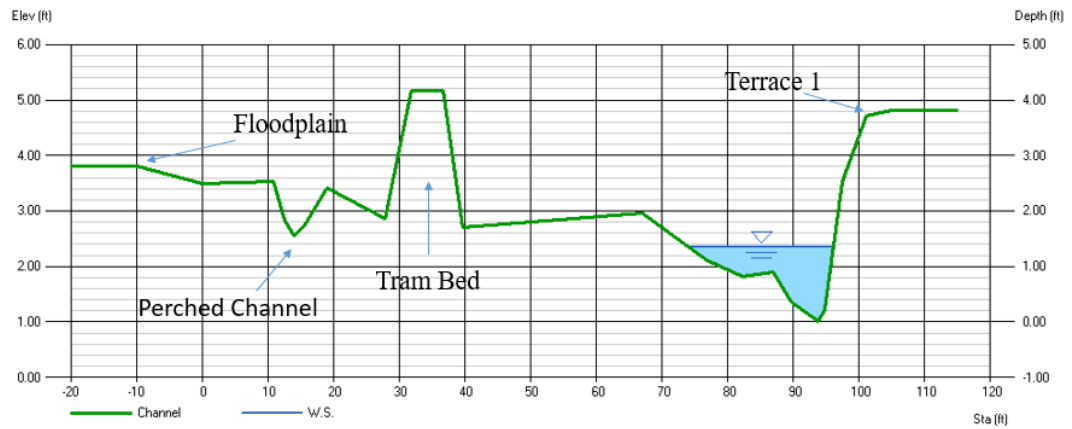
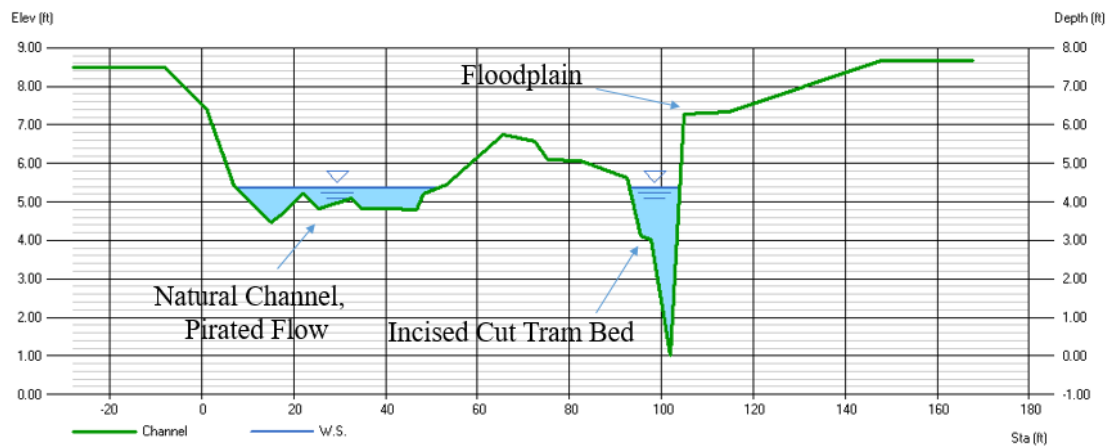
Figure 26. Cross-Sections. A.) Natural morphology, B.) Confined morphology, and C.) Tram Bed-Forced Morphology.

The tram bed is located in the valley for most of the confined channel reaches, and reaches heights up to 0.5 m above floodplains (Figure 26; Appendix B-2). Two confined reaches do not have the tram bed, but are located below other disturbed reaches where the tram bed is present. Channels with confined morphology have much more variation in valley landform elevation compared to natural reaches (Figure 26). Filled tram beds constrict channels, causing natural bankfull stages to be below total channel capacity. Filled tram beds also cause alterations to surface hydrology such as splitting of drainage on opposite sides of the tram bed, separating side flows from reaching the main channel, and causing headcuts to form due to constriction (Figure 9 and Figure 26).

Floodplain heights in tram bed forced morphologies range from 0.46 m to 1.9 meters (Figure 26; Appendix B-3) The cross-sections of tram bed forced morphologies have more variation in landform elevation compared to natural reaches due to incised channel beds along filled tram beds and in incised cut tram beds that pirate flow from the natural channel (Figure 10, and Figure 26). Cut tram beds can concentrate flow and can incise to form channels deeper than natural beds (Florsheim et al., 2000).

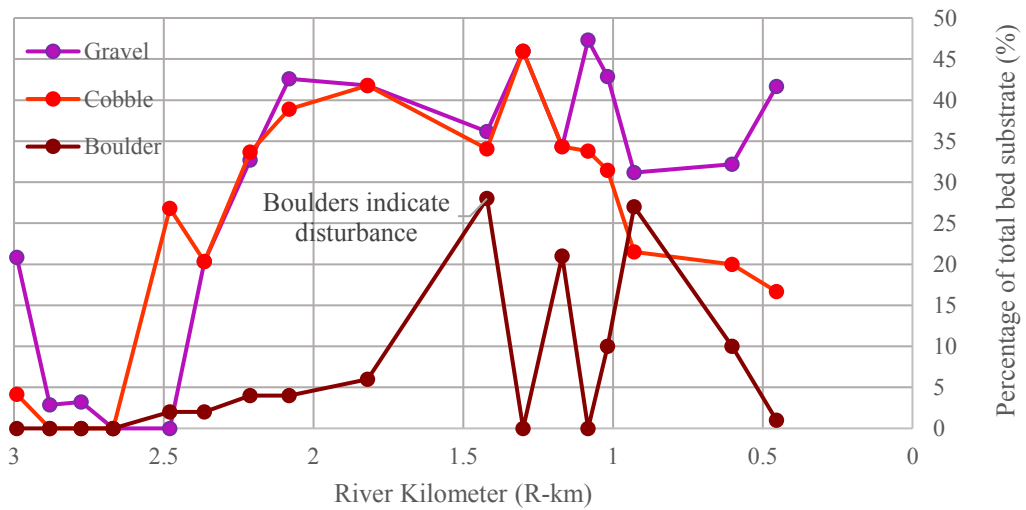
Figure 30. Alluvial Channel Substrates at Tram Hollow. Boulders indicate disturbance at Tram Hollow with high percentages being located along cut tram beds and constricted channels. No boulders were found in the natural reaches.

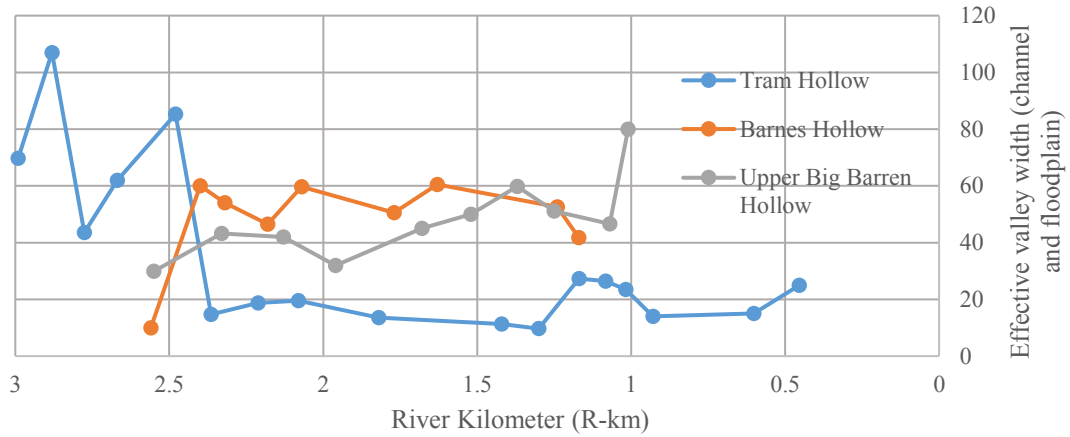
Figure 32. Effective Valley Width at Tram Hollow and Reference Channels.

Effective valley width, total channel width, and confinement (effective valley width / channel width) were quantified for Tram Hollow and two reference streams (Figures 32-34). Tram Hollow had relatively low effective valley widths compared to the two reference streams (Figure 32). The lowest effective valley width at Tram Hollow was 10 meters in the natural gorge and the highest was 107 meters in the relatively wide colluvial channels in the upper parts of the watershed (Figure 32). Barnes Hollow had effective valley widths that ranged from 10 meters in the headwaters to 61 meters. Upper Big Barren tributary had effective valley widths that ranged from 30 meters in the headwaters to 60 meters. Total channel width ranged from 10 to 22 meters at Tram Hollow, 0.7 to 6 meters at Barnes Hollow, and 2 to 10 meters at Upper Big Barren tributary (Figure 33). Confinement ratios ranged from 1 to 13 at Tram Hollow, 8.5 to 24 at Barnes Hollow, and 5.6 to 23 at Upper Big Barren tributary (Figure 34). The USFS defines confined channels as having confinement ratios of four or lower (Nagel et al., 2014). Almost all of the valleys with the tram bed had confinement ratios less than 4 (Figure 34 and Figure 35). Natural reaches with no tram bed influence had the highest confinement ratios, with all of them above four and ranging from 6.2 to 13.4.

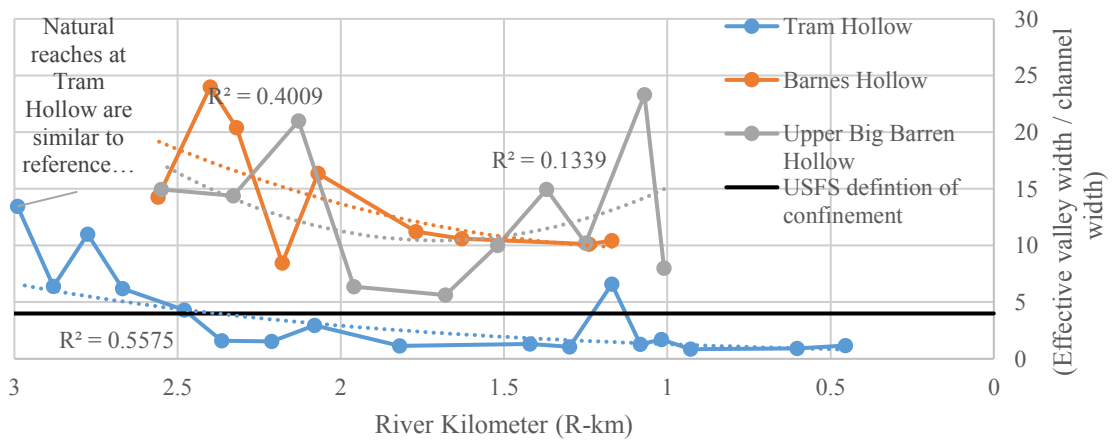
Figure 34. Confinement Ratio at Tram Hollow and Reference Channels.

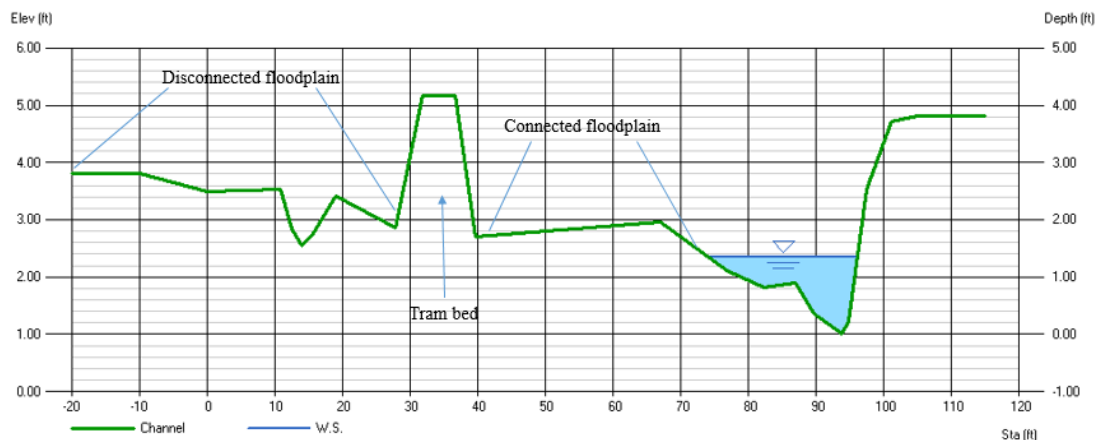
Figure 36. Floodplain Fragmentation.

The metric of lateral floodplain disconnection is the ratio of the area of the disconnected floodplain to the total floodplain area (Snyder et al., 2003; Blanton and Marcus, 2014). The boundary of disconnected floodplain is the distance from the active channel edge to the transportation line on the same side of the channel (Blanton and Marcus, 2014). The connected floodplain is the floodplain inside the transportation line, and the disconnected floodplain is the remainder of the floodplain (Figure 36). Floodplain fragmentation was calculated for all cross-sections at Tram Hollow (Table 8). Eight of the ten channel reaches where the tram bed was present had fragmented floodplains. Disturbed channel reaches had a range of floodplain fragmentation from 0% to 67% and had an average of 33%. In confined reaches, floodplain fragmentation ranged from 0% to 67% and had an average of 34.5%. In tram bed forced reaches, floodplain fragmentation ranged from 0% to 62% and had an average of 32.2%. All natural channel reaches had 0% floodplain fragmentation.
