Geomorphic Analysis of Lackman Tributary, Lenexa, KS.

Final report to Olsson Associates for the City of Lenexa, Kansas

December 17, 2009

OEWRI TR-09-004

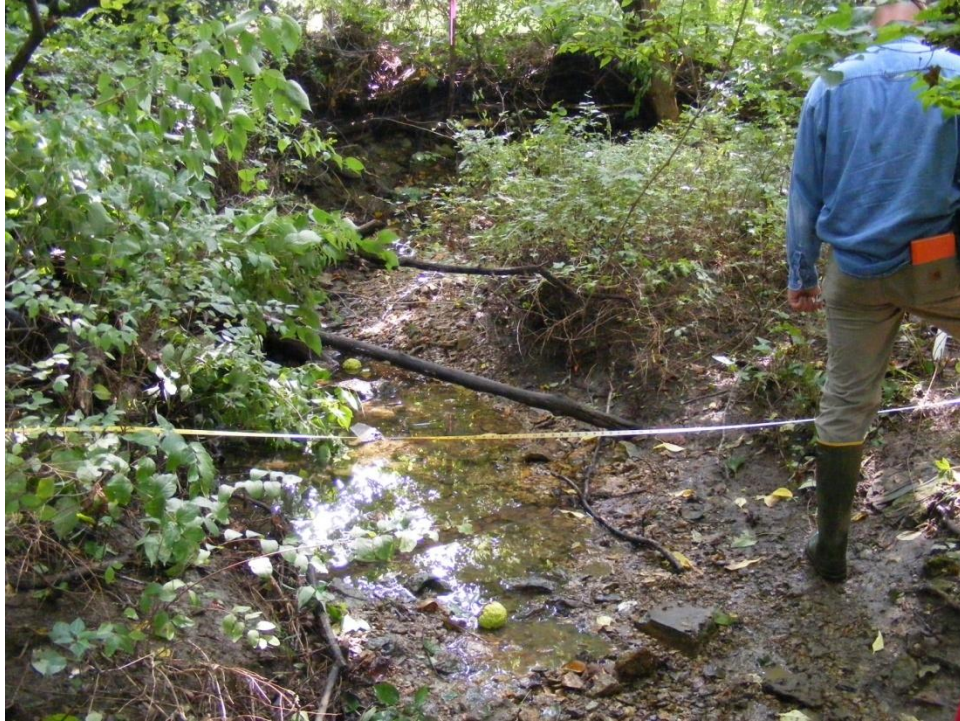
Photo 5. R4 – xs 2, St. 6,840, looking upstream (Sept. 2009)

This reach represents the transition of the stream as it flows from areas of deep upland soil and colluvial valley influence into an area of shale and limestone bedrock control. The bed consists of small cobble and gravel (Photo 5). A positive sediment budget is produced by: (i) relatively low slope; (ii) local supply of relatively coarse sediment by limestone bedrock weathering on the channel bed; and (iii) excess supply of finer bed material delivered from lateral channel erosion upstream in R-4. However, within the plane-bed channel, there is also a periodicity in bedform suggesting that it is really an inter-grade between riffle-pool and plane bed channel types.

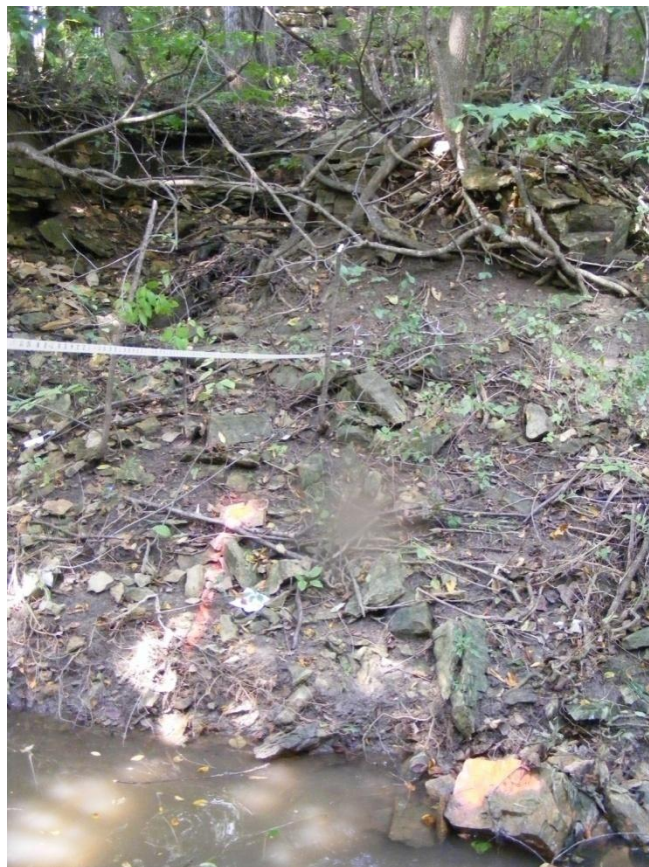
Photo 44. R14 – xs 15 St. 1,530 ft left bank (Sept. 2009)

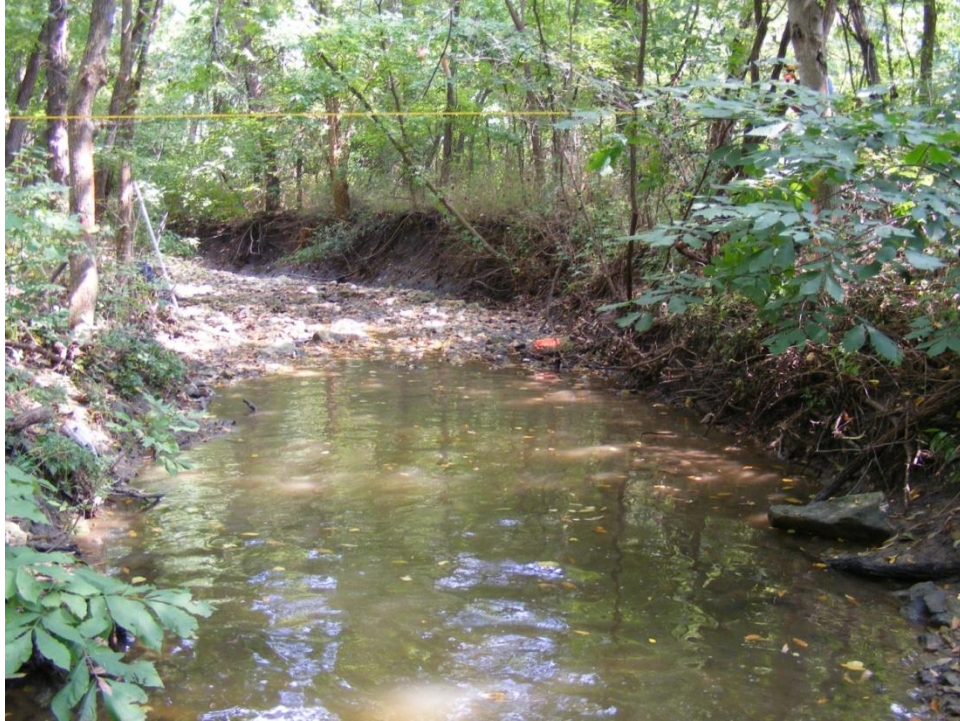
Photo 47. R15-A – xs 16 St. 890 ft looking downstream (Sept. 2009)

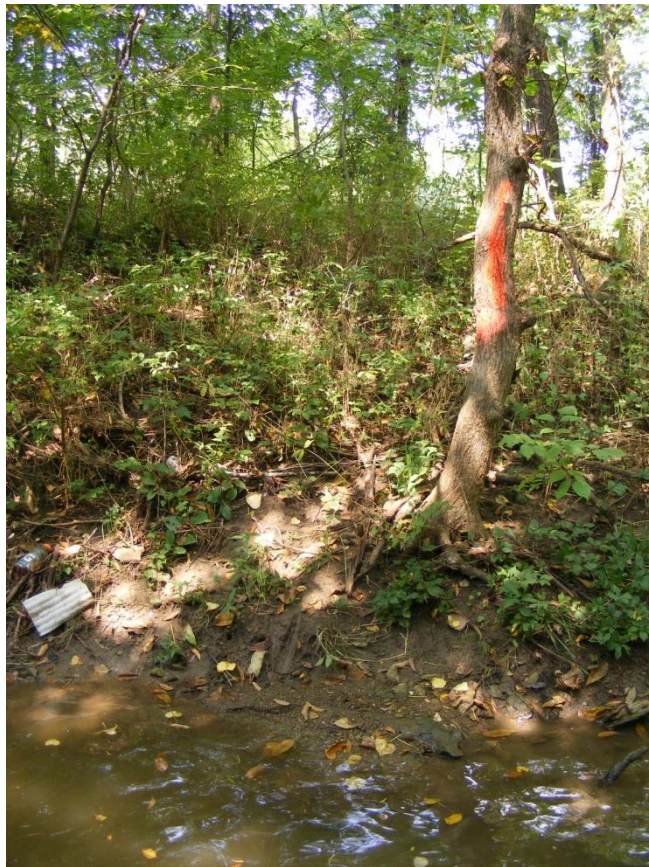
Photo 48. R15-A xs 16 St. 890 ft left bank (Sept. 2009)

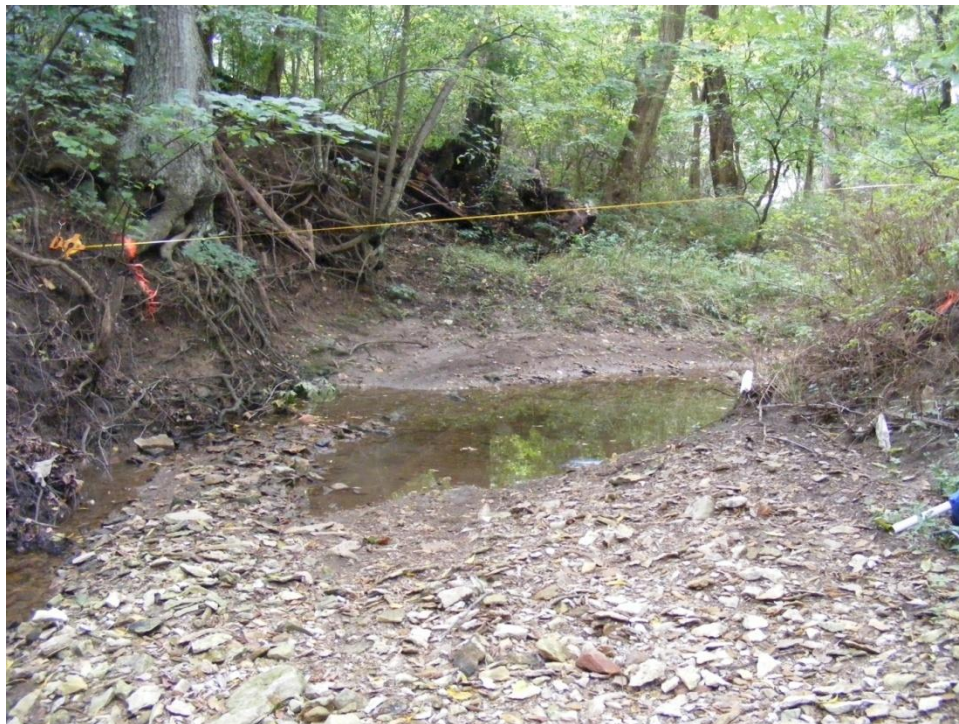
Photo 50. R15-B xs 17 St. 320 ft looking upstream (Sept. 2009)
