Ozarks Environmental and Water Resources Institute (OEWRi)

Geomorphic Analysis of Lackman Tributary, Lenexa, KS.

Final report to Olsson Associates for the City of Lenexa, Kansas

December 17, 2009

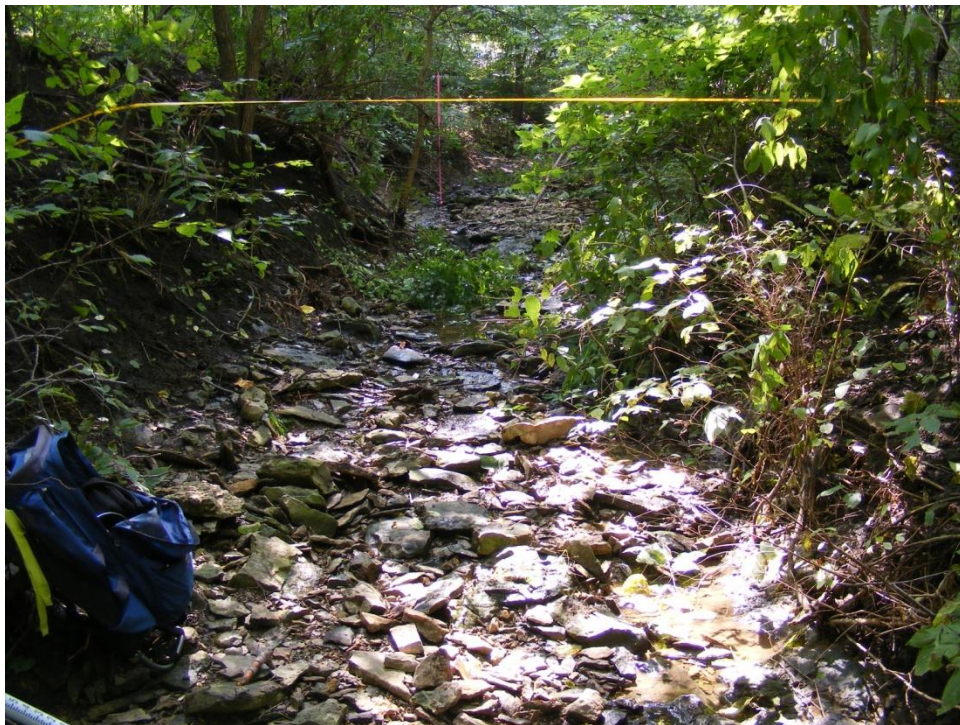
Photo 12. R6-C xs 6 St. 5,640 ft looking upstream (Sept. 2009)

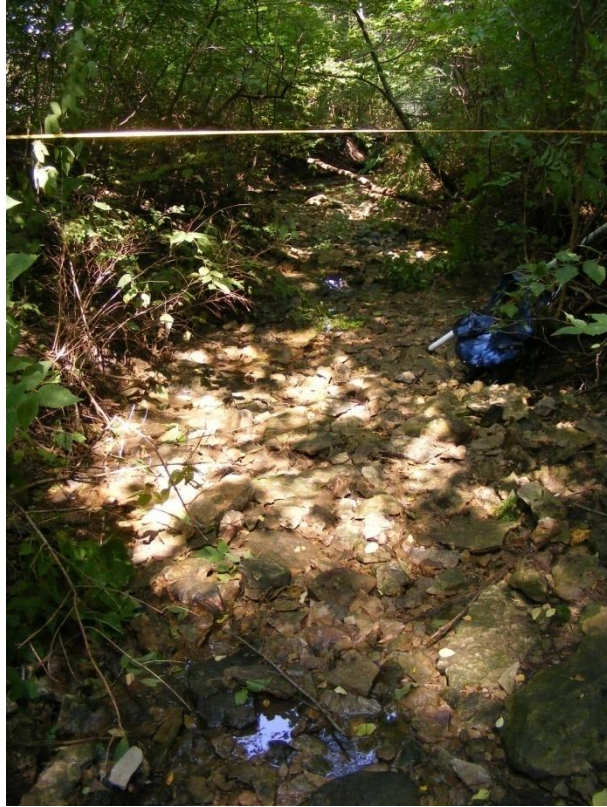
Photo 13. R6-C xs 6, St. 5,640 ft looking downstream (Sept. 2009)

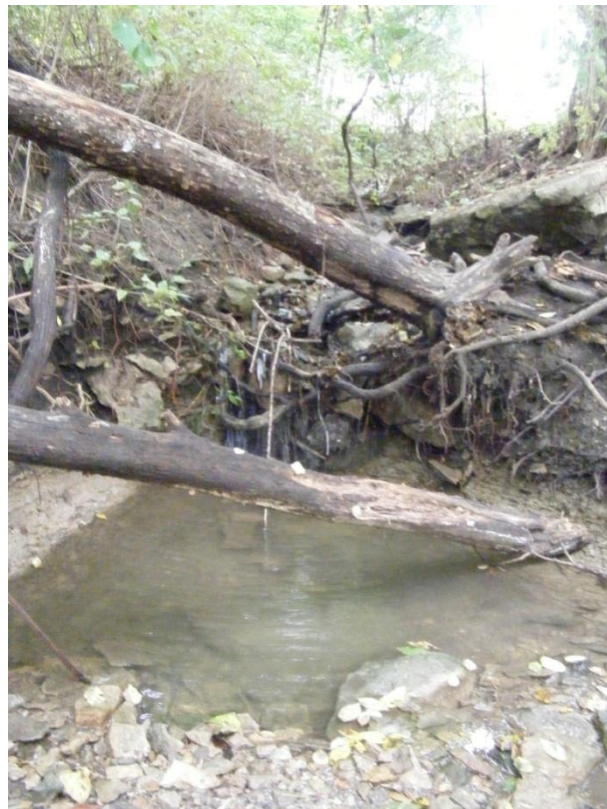
Photo 14. R6-C knick St. 5,550 looking upstream (Sept. 2009)

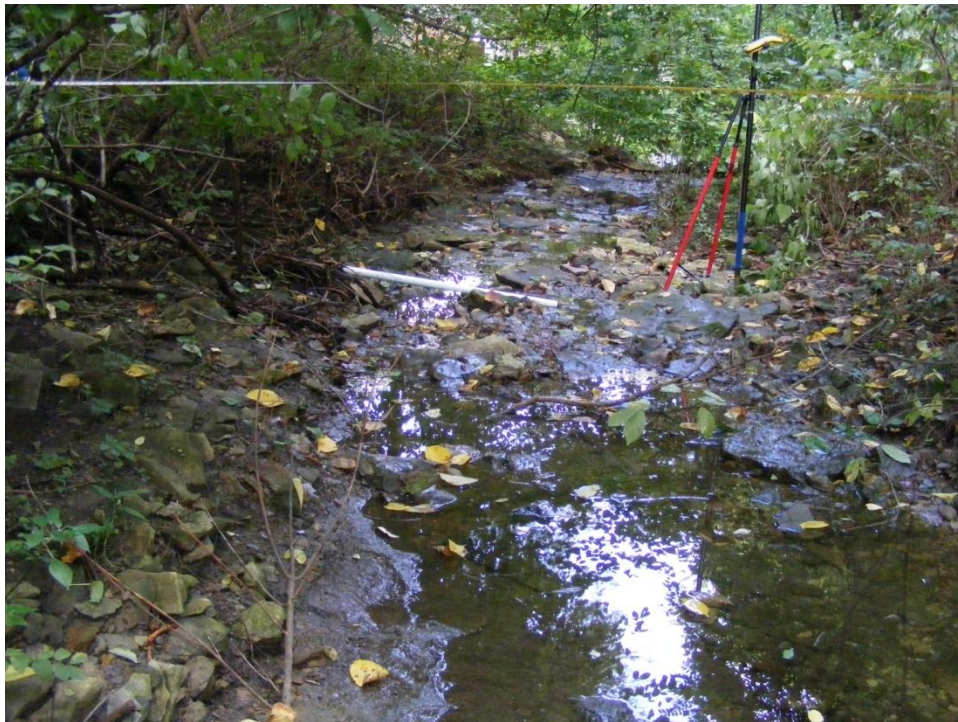
Photo 16. R6-C – xs 7, St. 5,280 ft looking downstream (Sept. 2009)

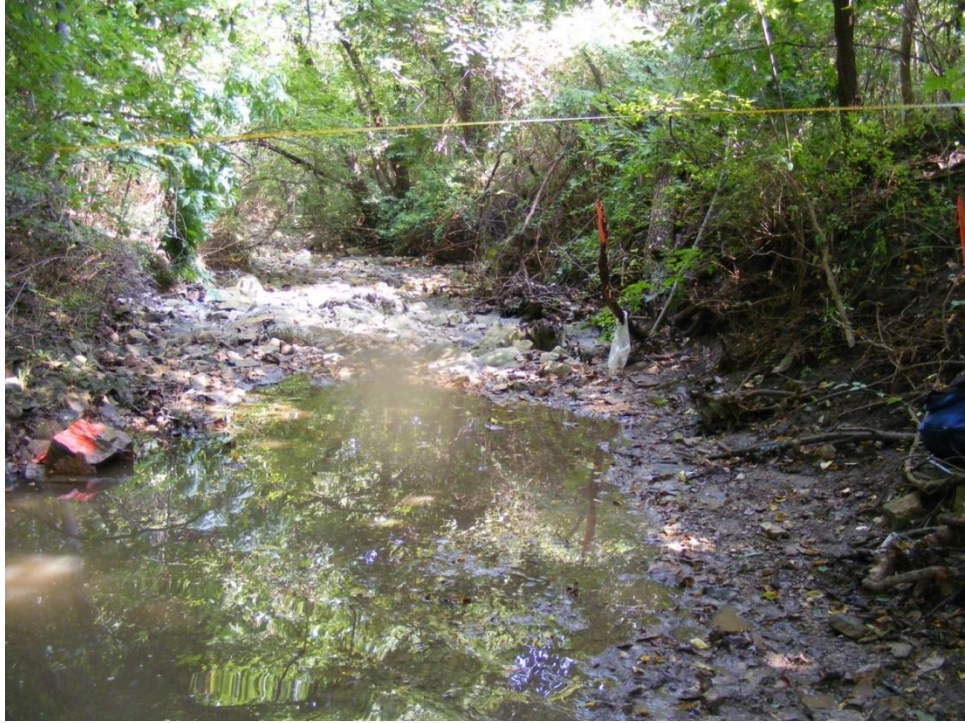
SR-14-C: Riffle-Pool Reach with bedrock control (Station 1,750-1,100 ft)- This sub-reach begins below obvious influence of the knick-point where the valley begins to widen slightly. There are relatively well formed floodplains found in several places along this reach.

Photo 43. R14 – xs 15 St. 1,530 ft looking downstream (Sept. 2009)
