WARD BRANCH STREAM RESTORATION PROJECT

POST-CONSTRUCTION ASSESSMENT

FINAL REPORT

OEWRi EDR-08-004

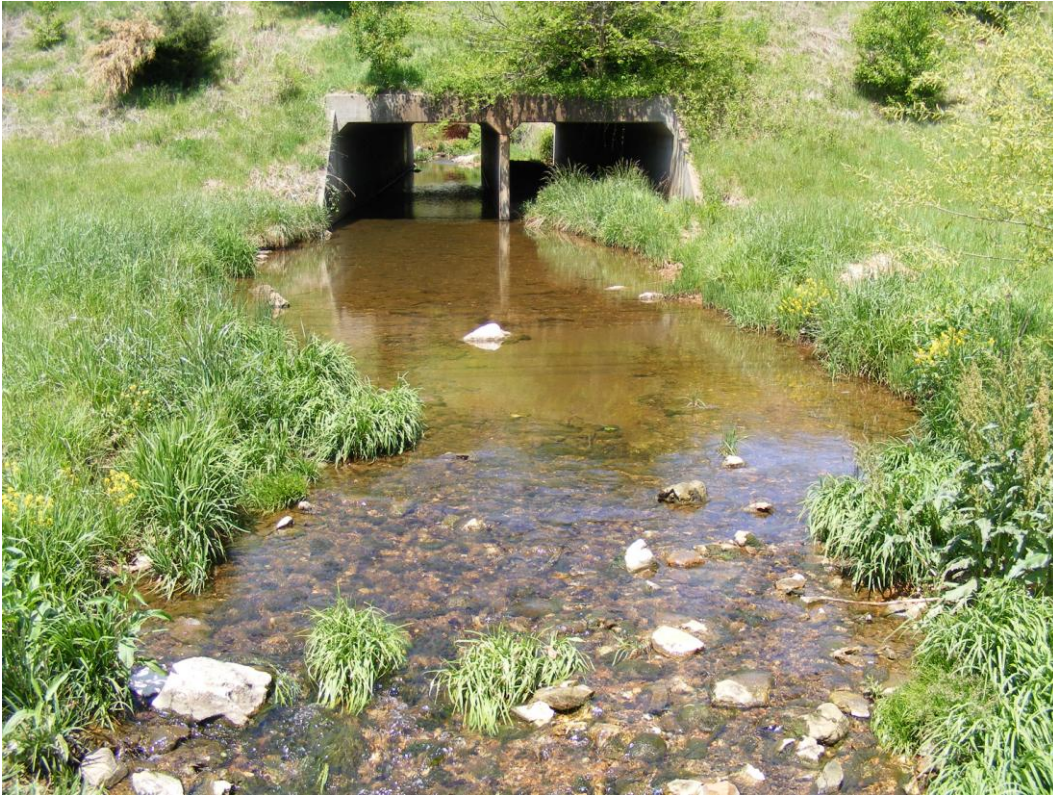
Picture 1. Republic Road bridge upstream of upper cart bridge looking upstream May 2008 (St. 100 feet)

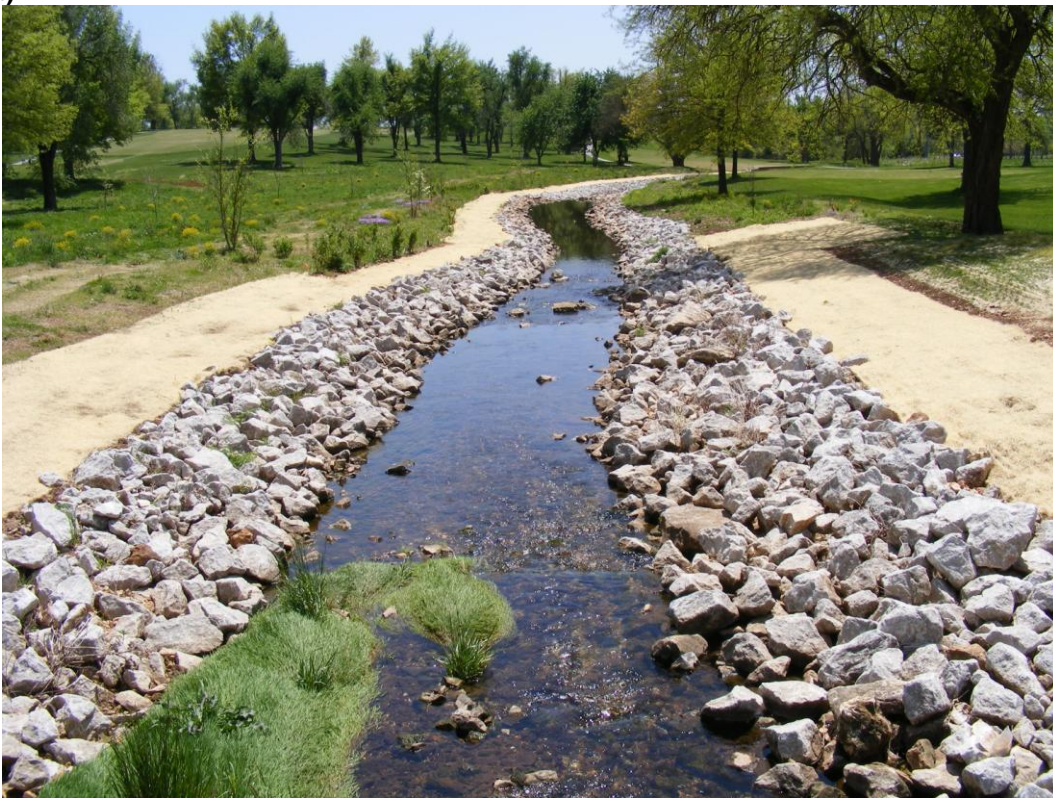
Picture 2. Downstream of upper cart bridge looking downstream May 2008 (St. 120 feet)

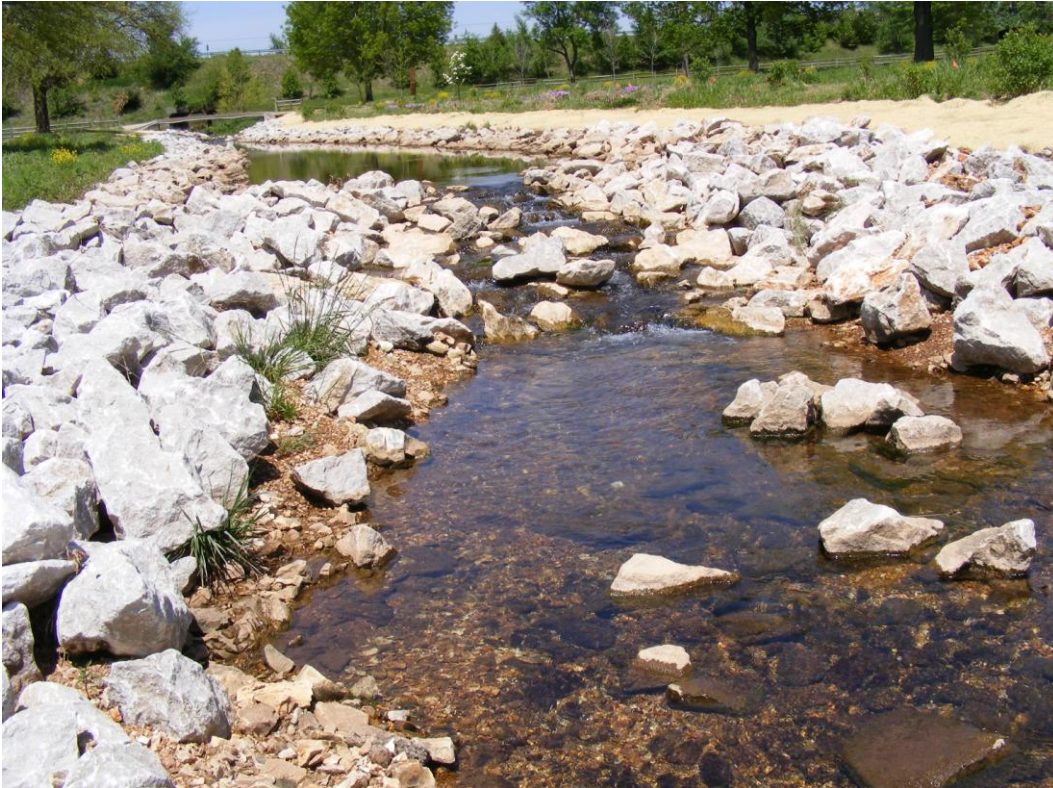
Picture 3. Example of grade control structure downstream of upper cart bridge looking upstream May 2008 (St. 450 feet)

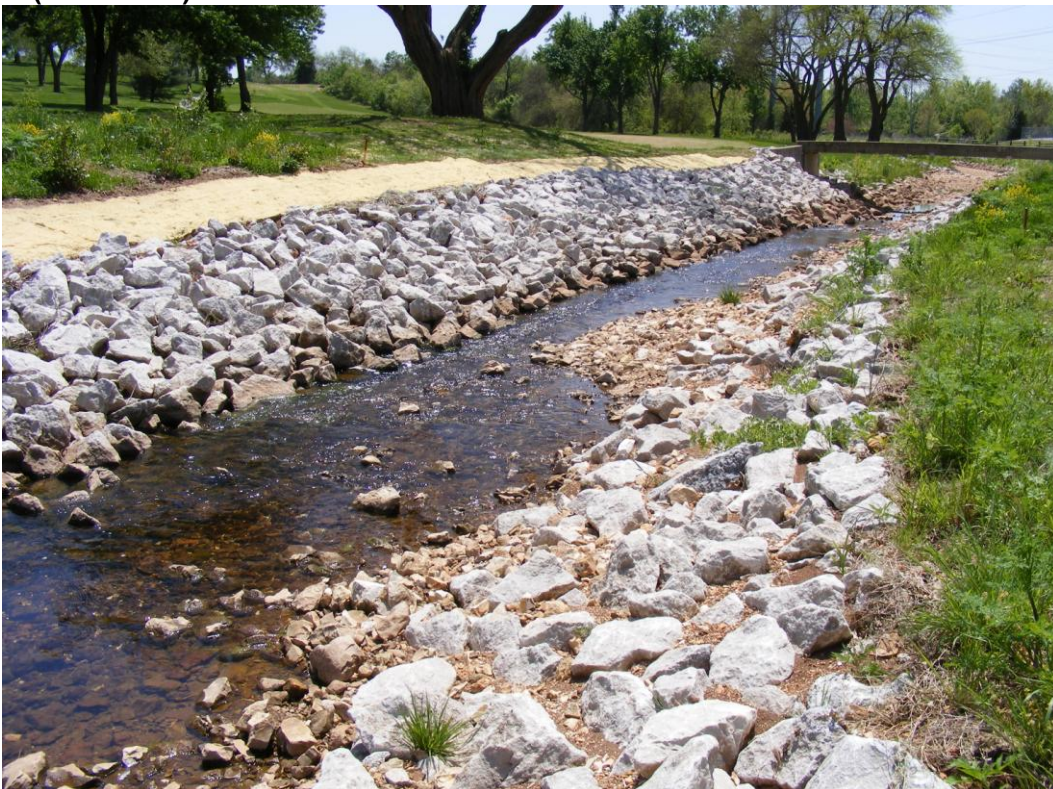
Picture 4. Upstream of lower cart bridge looking downstream May 2008 (St. 600 feet)

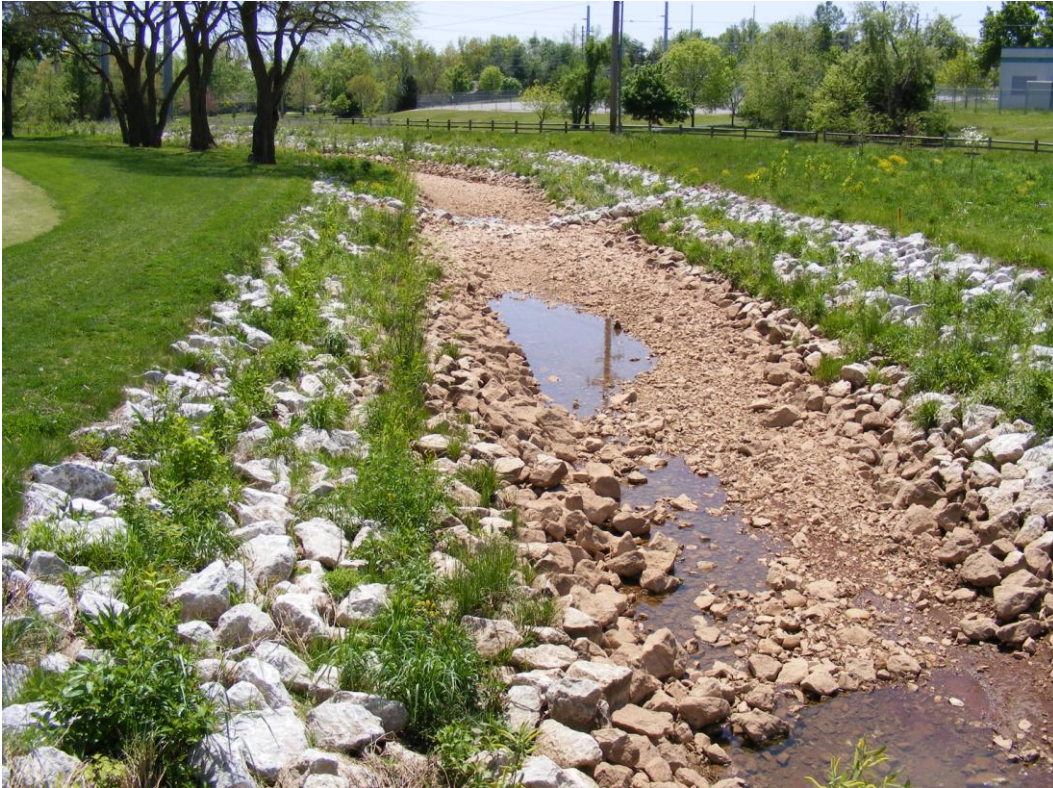
Picture 5. Below lower cart bridge and second grade control looking downstream May 2008 (St. 800 feet)

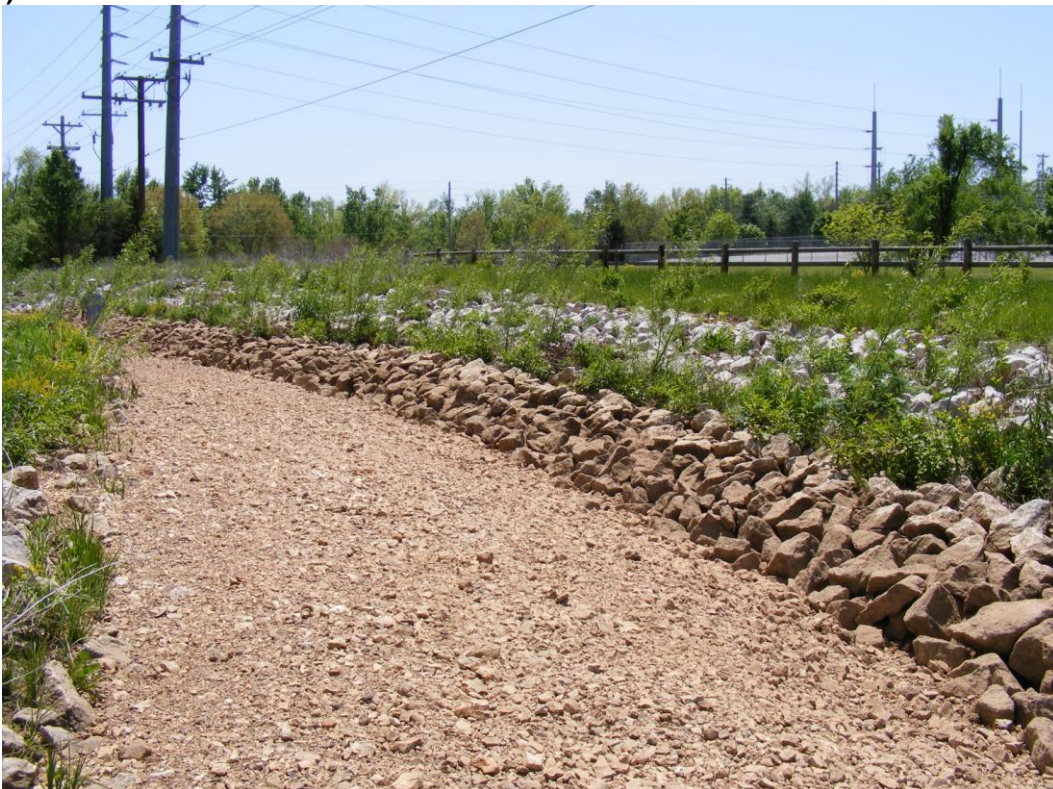
Picture 6. Composite revetment along the once active eroding reach looking downstream May 2008 (St. 1,000 feet)

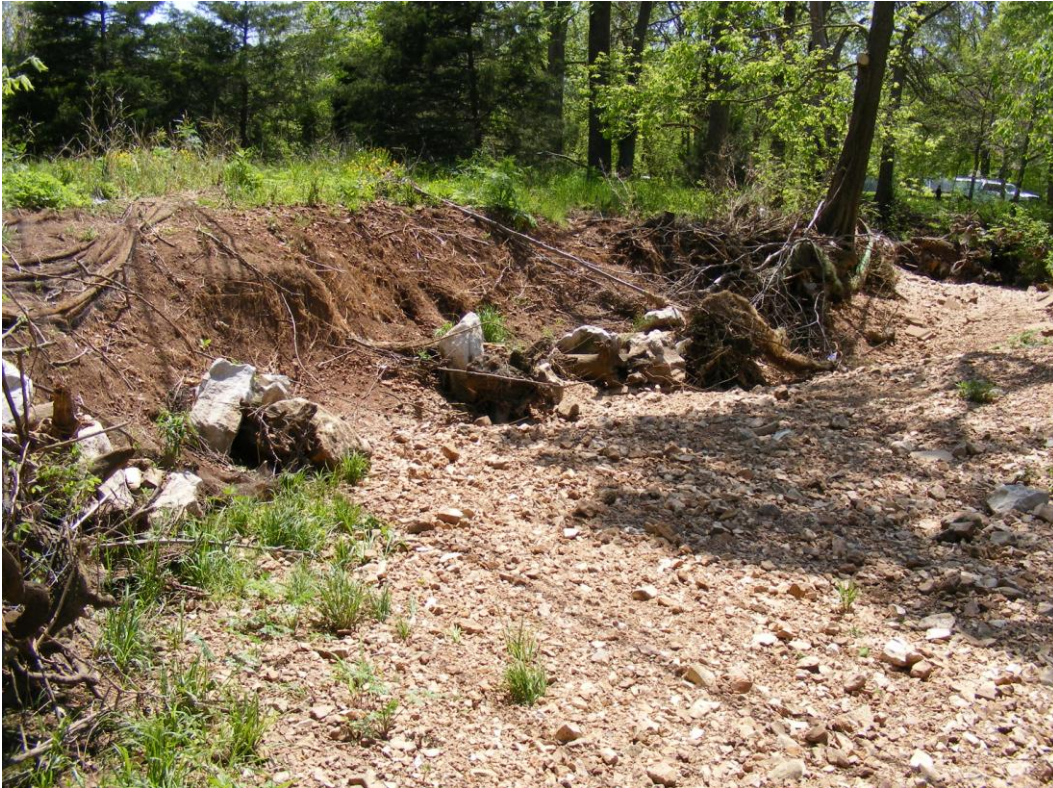
Picture 9. Root wads at meandering sub-reach looking downstream May 2008 (St. 1,650 feet)

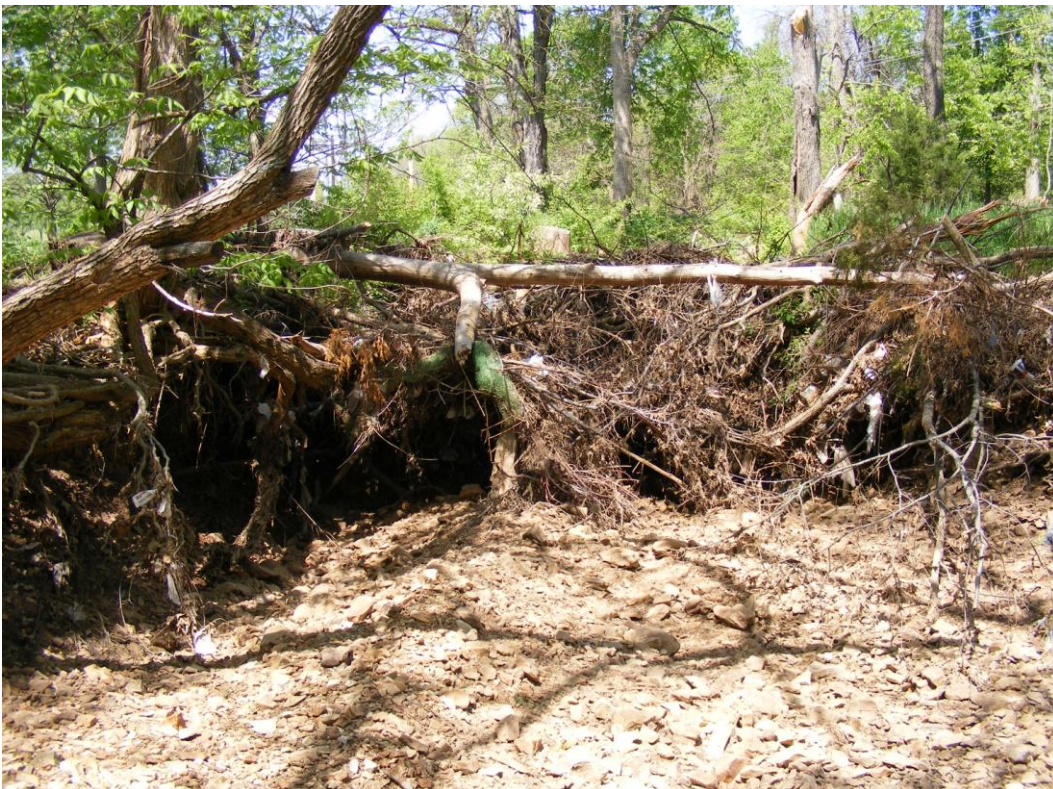
Picture 10. Large woody debris jam at station 1,730 feet looking downstream May 2008 (St. 1,730 feet)

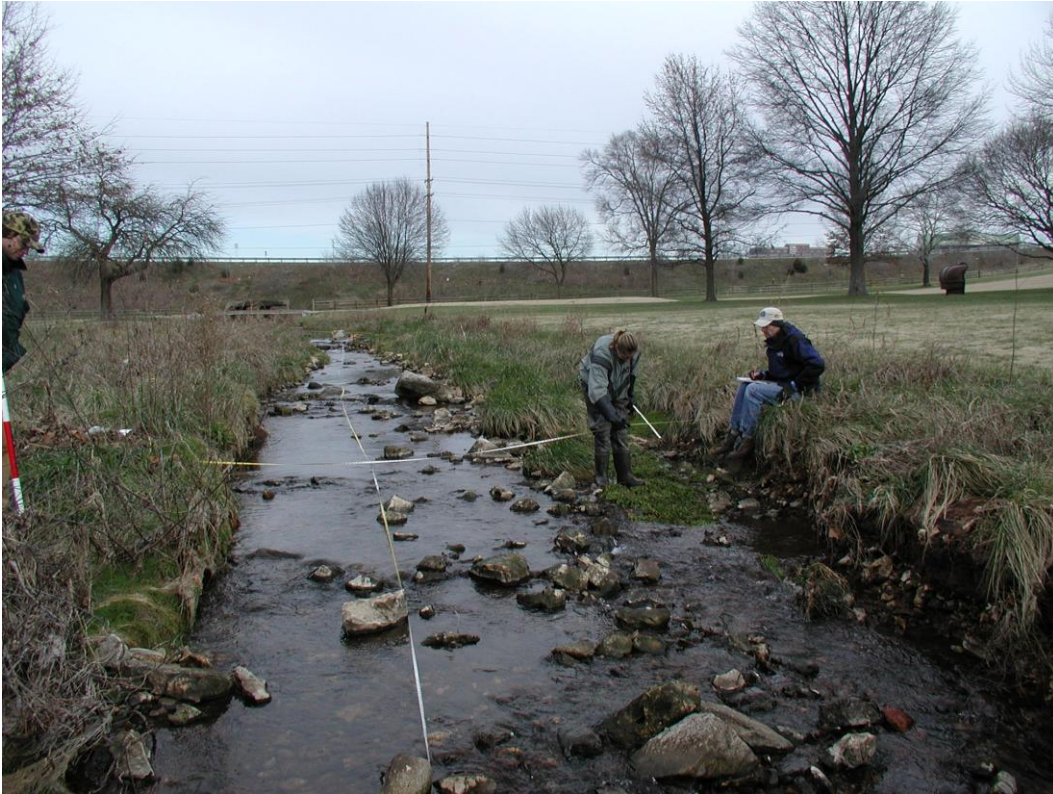
Picture 11. BEFORE - Riffle below first cart bridge looking upstream December 2004 (St. 400 feet)

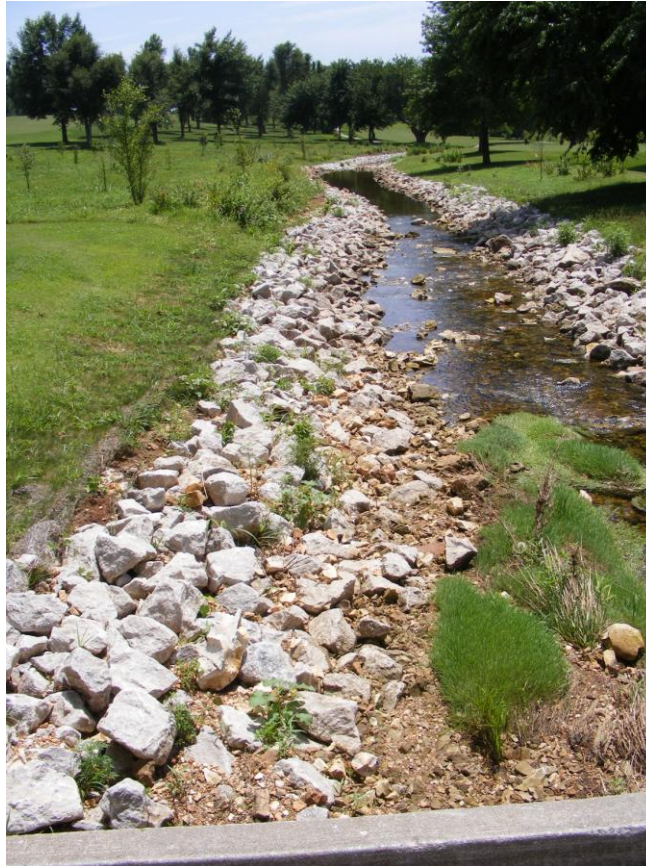
1. Erosion is occurring behind the toe protection along the east bank of the stream between stations 200 and 300 feet on the inside of a bend in the channel (Picture 21).

Picture 21. Looking downstream of first cart bridge July 2008. (St. 120 ft)

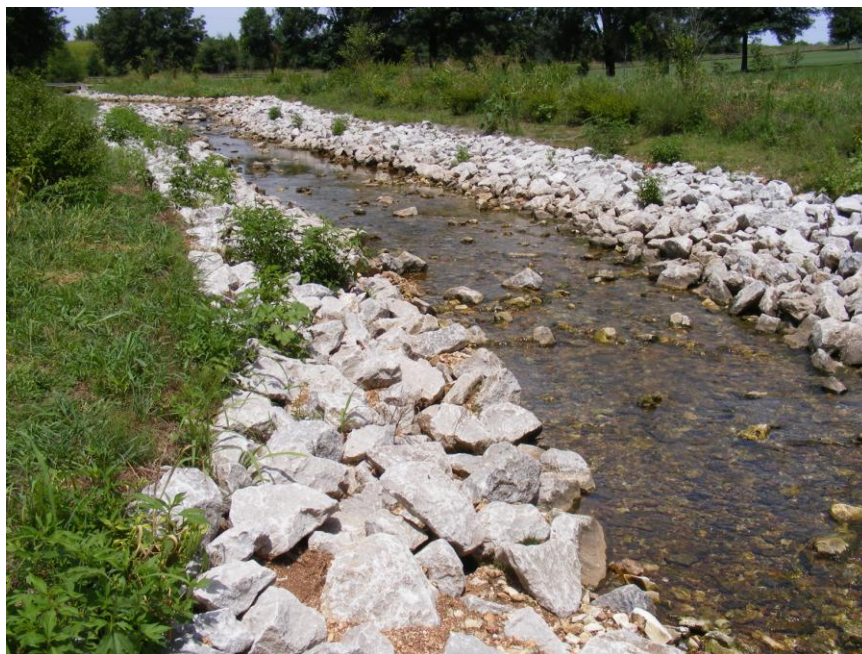
Picture 22. Step-pool reach below first grade control structure, July 2008 (St. 500 ft)
